# NATIONAL SLATE ASSOCIATION

## Technical Bulletin No. 8: Corrosion and Wear of Metal Flashings

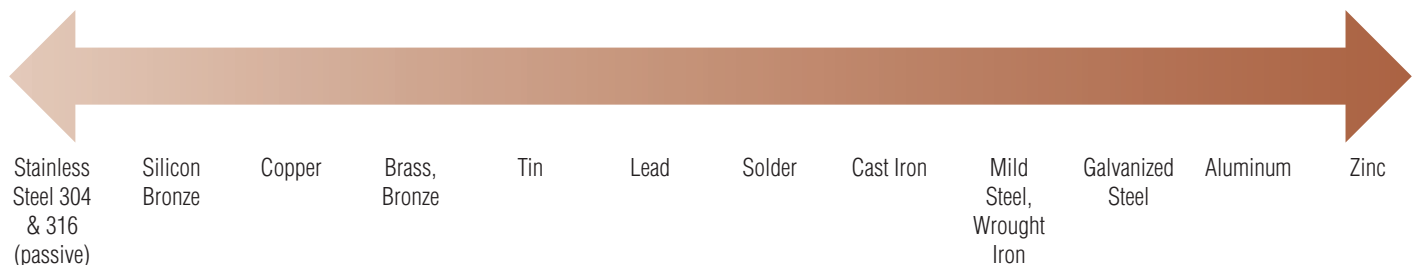
Also known as electrolysis, galvanic corrosion is a chemical reaction that occurs between dissimilar metals in the presence of a liquid that can conduct electricity - the same process as a battery. In roofing projects, the dissimilar metals could be fasteners that are different from the flashing metal, and the liquid could be rainwater, dew, or condensation. Near the seashore, spray from salt-water could also provide the liquid, which is much more conductive than rainwater, and would speed the reaction. Some metals are more reactive than others. Metals commonly used in construction are listed in the accompanying chart, in order from most noble (least reactive) to least noble (most reactive). The farther apart metals are on the galvanic chart, the more likely galvanic action will occur between them, resulting in the less noble metal sacrificing itself to the more noble. For more on galvanic corrosion, see NSA's *Slate Roofs – Design and Installation Manual*, 2010 edition, p. 37.

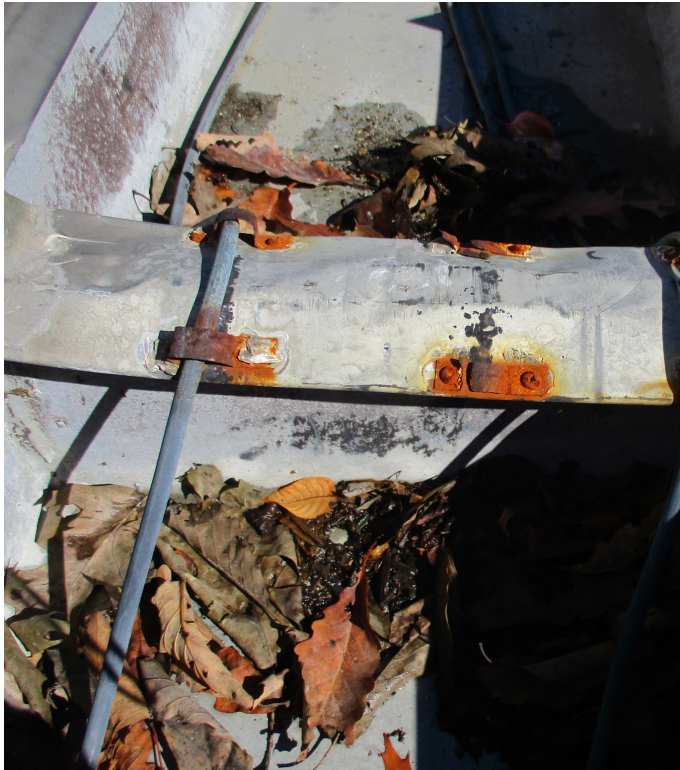
The above photo shows de-icing cables that were fastened to a lead-coated copper expansion joint with steel screws and straps. The “less noble” screws and straps have corroded badly, while leaving the copper intact. This illustrates the process of the less noble metal corroding in the presence of the more noble copper. Corrosion could have been avoided by using copper straps and rivets, or fasteners that are closer to copper in the galvanic series, such as brass, silicon bronze or stainless steel.

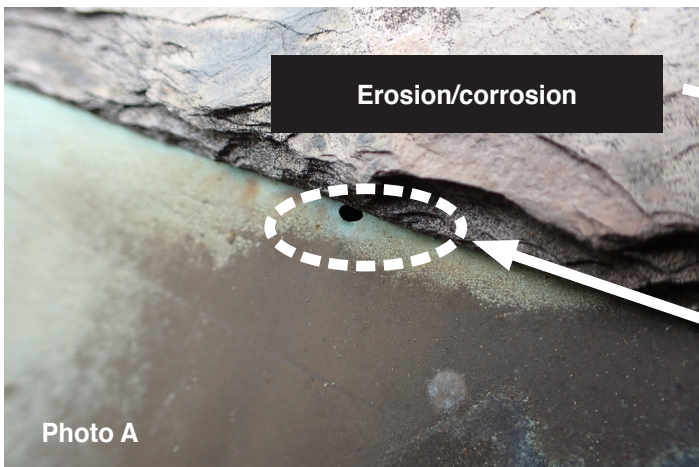
Localized pitting of copper can occur due to a chemical reaction that breaks down the protective patina on the surface of the copper. As stated in *Copper and Common Sense*, “A drop of water on the surface of a metal excludes oxygen from the small area it covers. This results in a flow of electrons from the ‘oxygen starved’ area under the drop to the ‘oxygen rich’ areas near the edge of the drop. The resulting flow of electrons causes a pit to form.” This type of corrosion occurs where drying takes place slowly, such as along the butt end of the slates where they terminate at valleys or built-in gutters, and is referred to as “line corrosion.” See photos A and B.

1. When inspecting a slate roof, or investigating leaks, check carefully at the locations where water drips off the slate onto copper flashings. Such locations would be at valleys, built-in gutters, chimney crickets, vent-pipe flashings, etc. The pitting and wear start very small, and can be difficult to see at first. Take note of color differences in the copper; when the copper becomes thin it turns a yellow-orange color. Temporary repairs can be made with a variety of patching materials, but avoid applying these materials to the slates themselves – only patch the copper flashings. The proper repair is to remove slates adjacent to the worn copper, replace the copper flashing, and re-install the slates. Other options may include inserting a replacement flashing below the slate shingles and over the worn areas of copper. There are also many fluid-applied membranes that can be used for localized repairs, but, again, these should not extend onto the slates themselves.

3. The bottom course of slate should be raised slightly by use of an integral copper cant as illustrated in *Slate Roofs: Design and Installation Manual*, a wood cant clad in copper, or a composite wood cant. The resulting separation between the slate and the copper will help limit the conditions that cause line corrosion.

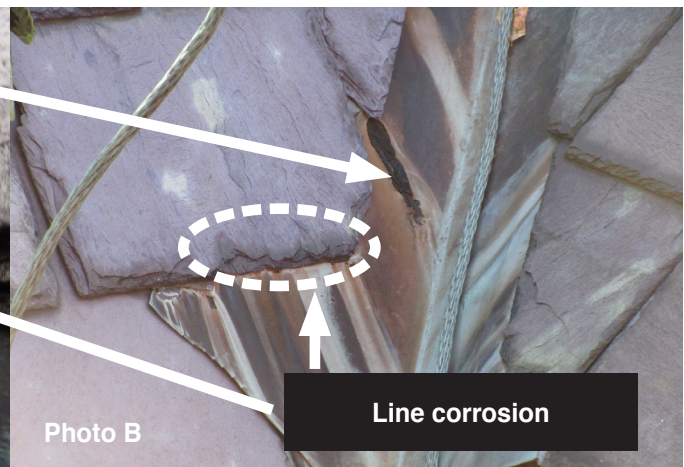
Copper’s protective patina can be removed by water running off, or dripping off, the butt ends of the slate. The run-off from the slate can contain abrasive particles that continually wear down the copper (see Photo B). Damage to the copper can result not only from water run-off causing physical erosion, but also from a chemical process. When

dew forms on the roof, the drops of water slowly run down the slope; along the way, environmental impurities are dissolved into the water, making the water acidic. As the water trickles down the roof, some water evaporates, making the acid more concentrated. Some of these acids remove the protective patina and gradually corrode the copper.
