Technical Bulletin #7 **NATIONAL SLATE ASSOCIATION**

Slate Roof Condition Assessment Surveys

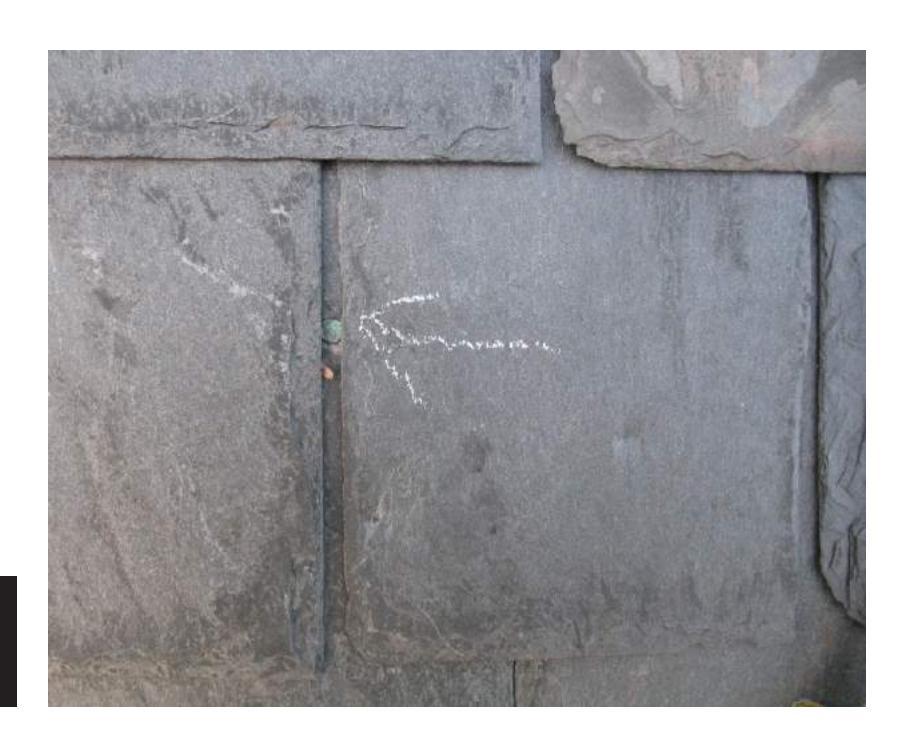
During the field survey portion of the condition assessment, broken and missing slate shingles can generally be seen from afar - from grade using the naked eye and/or binoculars. It is important to observe the slate upclose as well, to look for such things as cracked slates, exposed nails within the bond lines of the slates (Figure 2), wear holes caused by the heads of the slating nails working their way through overlying slates (Figure 3), and delamination.

Figure 2: Exposed copper slating nail within a bond line; in this case the result of the use of a narrow slate and insufficient offset.

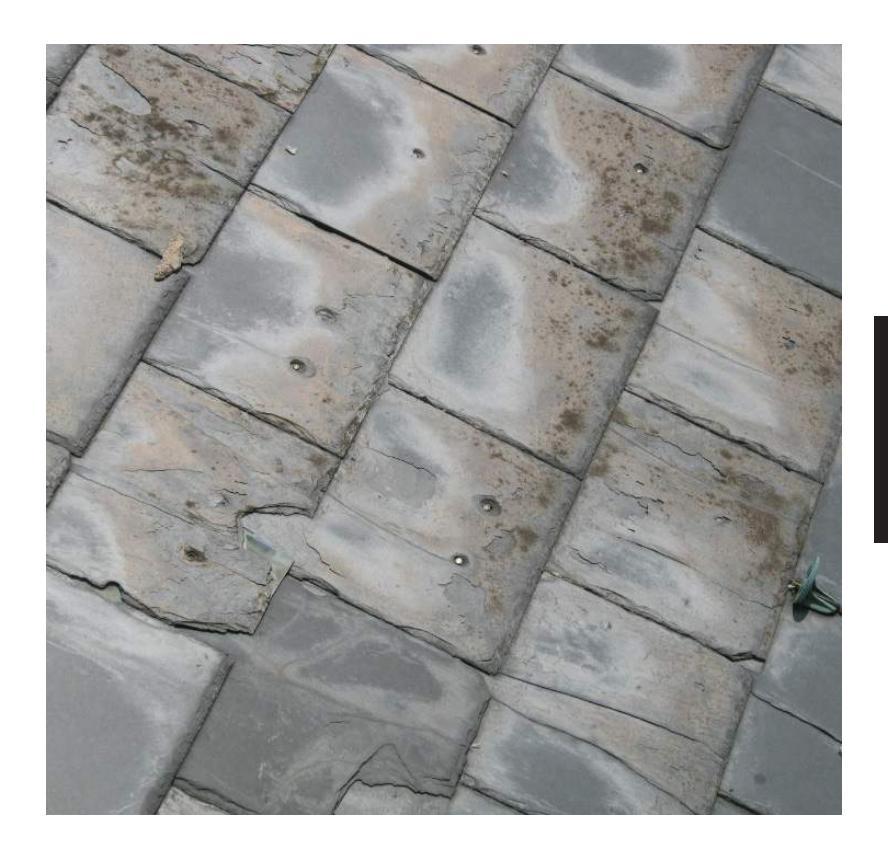
Figure 3: Cracked and broken slates, as well as holes caused by under-driven slating nails working their way through overlying shingles in this c.1966 Pennsylvania Black slate roof.

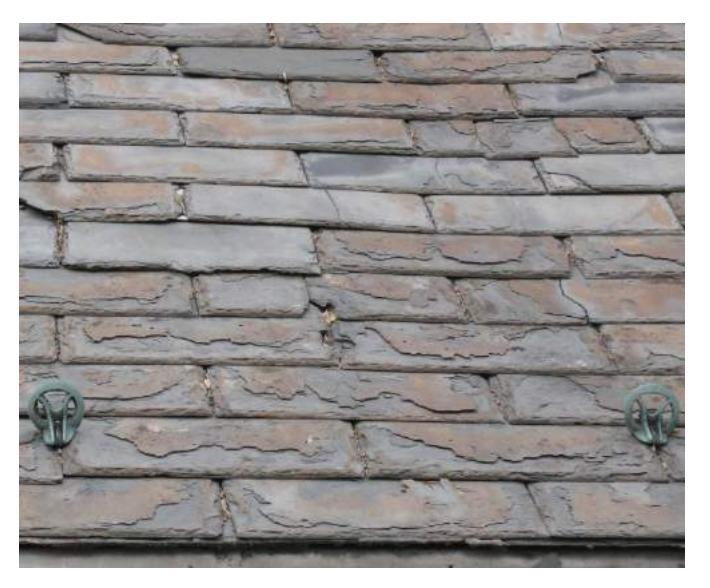
Delamination occurs when impurities contained within the slate (primarily calcite and iron sulfides, such as pyrite and marcasite) react, in association with hot/cold and wet/dry cycling, to form calcium sulfate (gypsum) molecules that take up slightly more volume than the original minerals.5 This gradually pushes the slate apart along its cleavage planes, eventually manifesting itself as the paper-thin laminae we observe on the exposed and hidden faces of the slate (Figure 4). As the slate delaminates, it becomes softer and more prone to breakage. It also tends to hold moisture longer, thus becoming susceptible to freeze/ thaw damage. The moisture retained in the slate can also begin to cause the wood roof deck to rot, especially if the original felt underlayment is in poor condition. The lower the slope of the roof, the greater the rate of weathering and deterioration as the slates tend to stay wet for a longer period of time after each precipitation event.

Figure 4: Severely delaminated slate shingles. The relatively low slope of the roof (5:12) helped to accelerate the rate of deterioration.

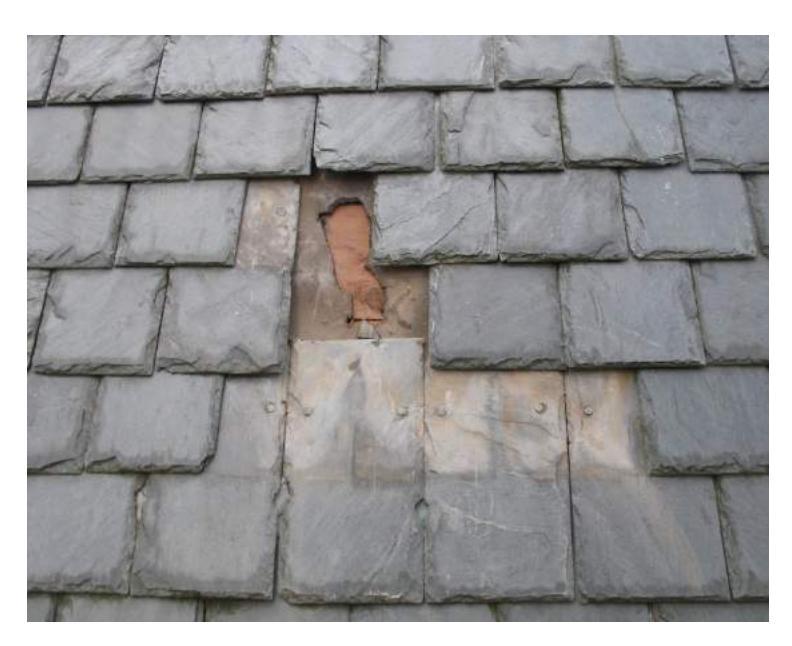
Figure 5: Test opening in a 90-year old roof with a slope of 14:12 and covered with slate shingles from the Monson District, Piscataquis County, Maine. The slate, hot-dipped galvanized slating nails, and felt underlayment were found to be in good condition.

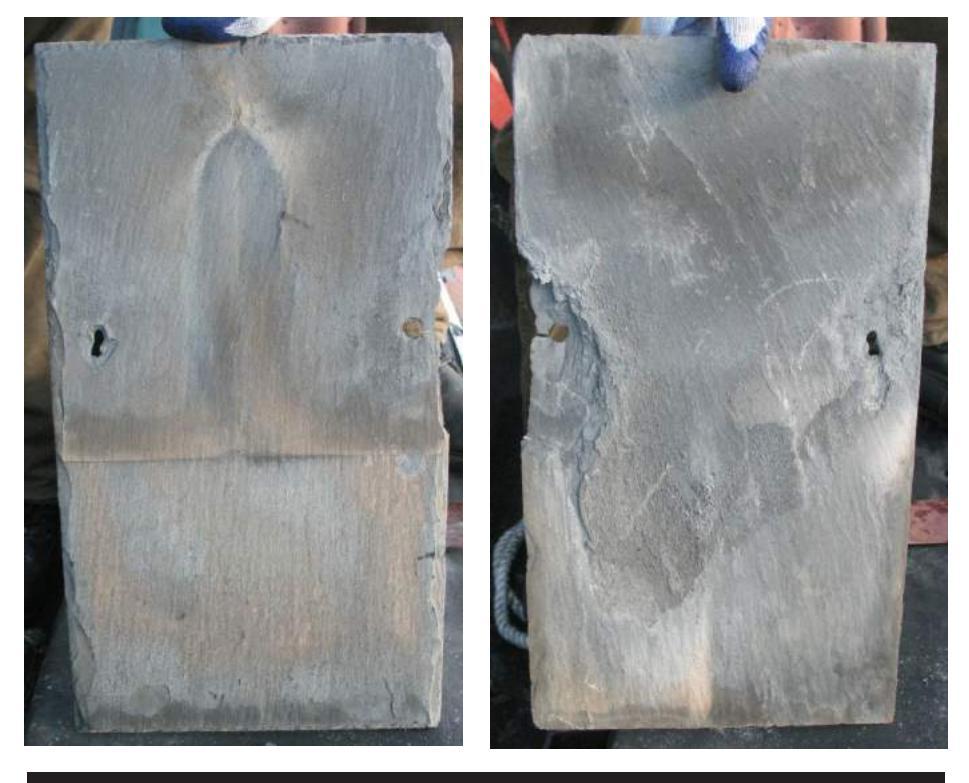
It is important to observe the back side of the slate shingles because it will sometimes be found to be in "worse" condition - that is exhibiting a greater degree of delamination - than the exposed portion (Figure 6).

Figure 6: The exposed portion of this slate (left) exhibits little to no delamination. The unexposed face (right) exhibits a good deal of delamination, especially around the nail holes, where the loss of section is significant.

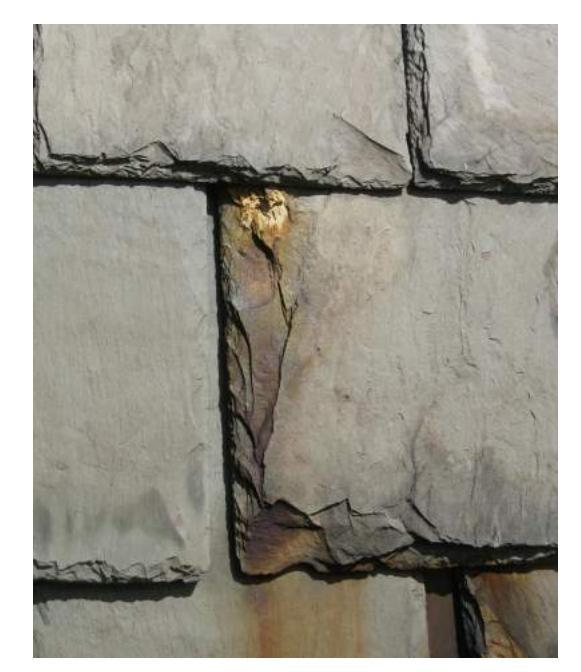
The presence of oxidizable iron pyrites in slate shingles can cause rust staining on the surface of adjacent slates and appear unsightly. The condition, sometimes called "rusting-out," occurs most often in New York/Vermont weathering green slate, but sometimes in unfading green as well. The condition is typically isolated to a relatively few slates. When in an advanced state, the affected area can be flakey and soft due to the increased volume of the oxidation product compared to that of the original pyrite (Figure 7). Replacement of the slate is required to prevent further deterioration and staining.

Figure 7: Oxidized iron pyrite in an isolated New York/Vermont Unfading Green slate on a dormer cheek wall

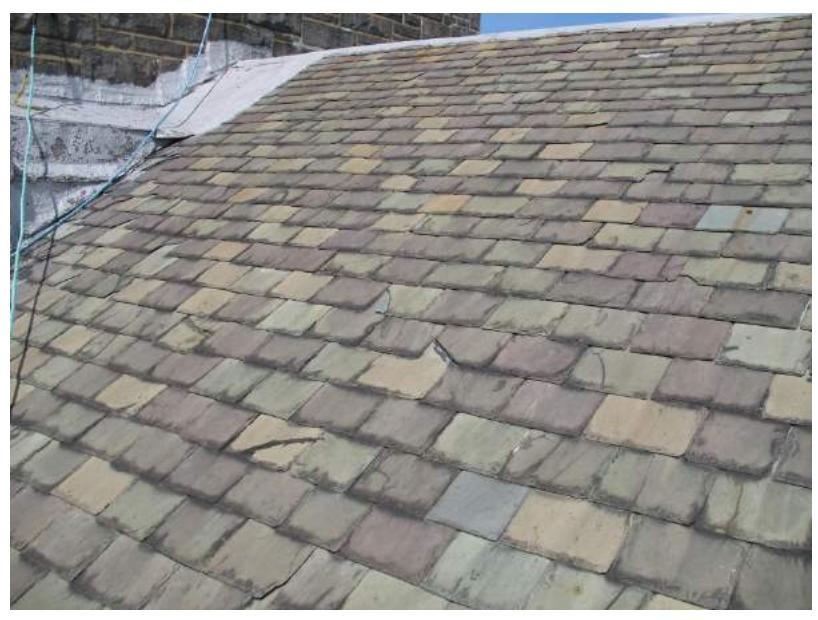
As a general rule of thumb based on past experience, if 20-percent or more of the slate shingles on a roof are broken, cracked, missing, sliding out of position, severely delaminated, or suffering from inappropriate past repairs (e.g., face nailed, undersized), then it is often more practical and cost effective to replace the roof than to attempt individual repairs (Figures 8 and 9). This assumes that the deteriorated slates are randomly located, rather than being concentrated in one or two locations.

Figure 8: Sometimes it is necessary to count slates to determine the percentage of broken or otherwise deteriorated shingles present on a roof. Here, roughly 72 of the 369 slates captured in this photograph (19.5%) are in need of repair.

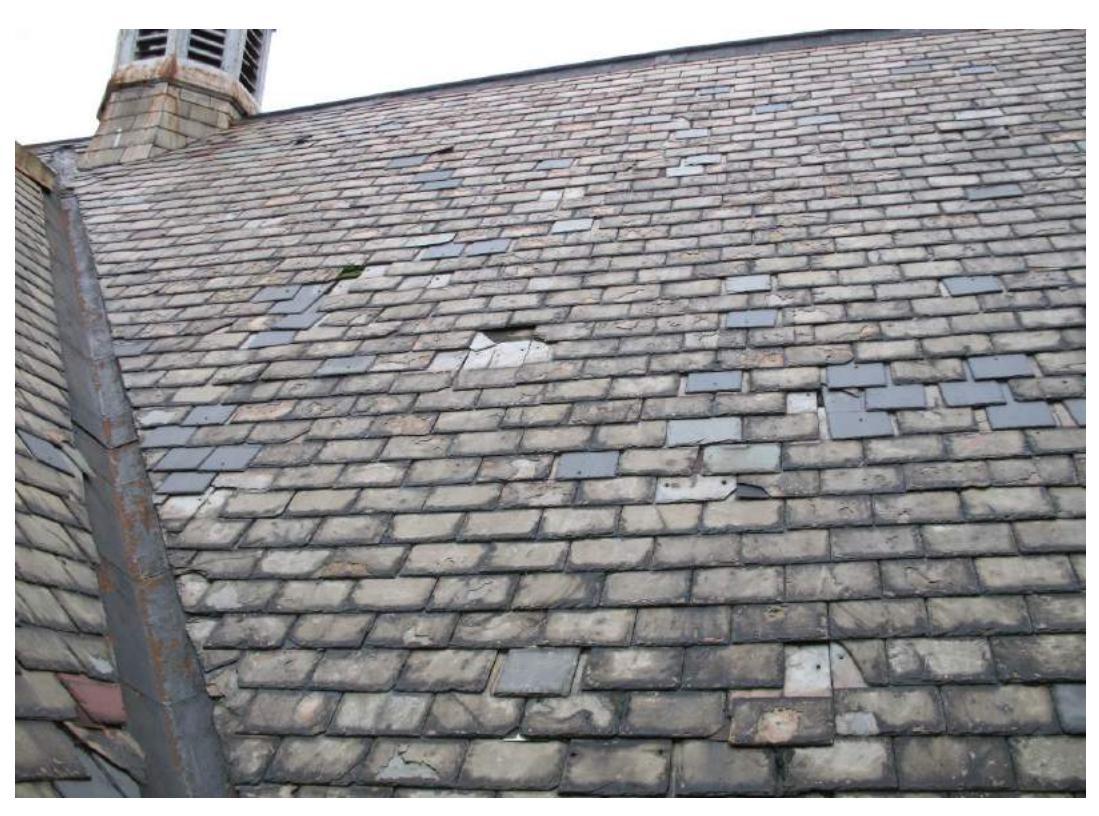
Figure 9: Widespread severe delamination in these 120-year-old **New York/Vermont** unfading green slates, combined with broken, cracked, and missing slates, face-nailed and undersized slates stemming from inappropriate repair work, slates sliding out of position, and the corroding terne metal open valley, makes roof replacement a straightforward decision in this case.

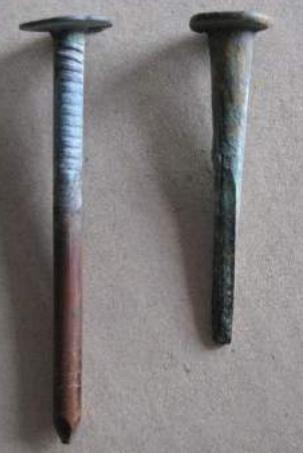
Various types of nails have been used to secure slate shingles over the years. Copper and stainless steel slating nails will typically be found to be in good condition (Figure 10). Steel/iron cut nails and steel wire nails, and the electroplated versions of these, with only a minimal zinc coating, will often be found to be in poor condition with either their heads corroded off (Figure 11) or that portion of the shank located just above the roof deck corroded nearly through. A common manifestation of corroded fasteners is individual slate shingles sliding out of position (Figure 12).

Figure 10: Ninety-year old copper wire slating nail (left) and 120-year old bronze cut nail (right), both in good condition.

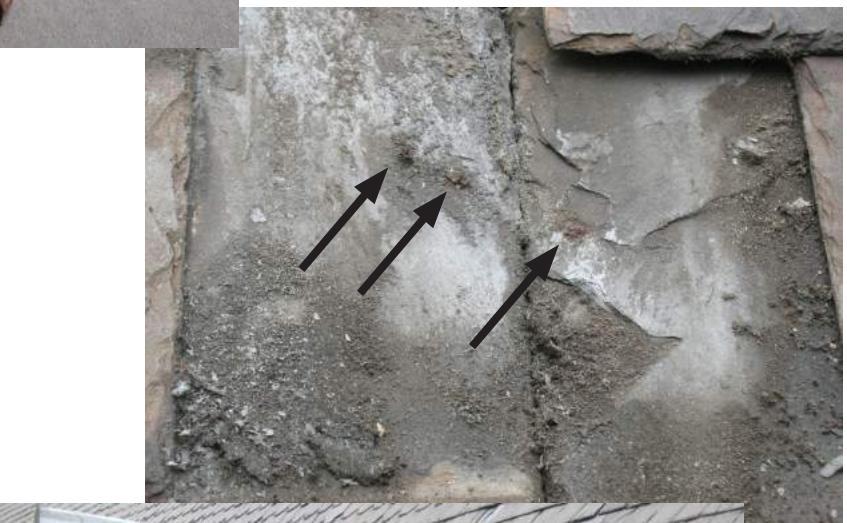
Figure 11: Corroded steel cut nails on a 145-year old slate roof.

It should be verified whether fastener corrosion is widespread or localized in areas subject to concentrated water flows, such as below dormer valleys or below where a low-slope roof drains onto the slate roof. If the condition is typical and widespread, it is likely time to replace the roof, lest more shingles continue to slide down-slope, or the shingles become subject to blow-off in high winds. If the corrosion is localized, removal and reinstallation of the slates may be possible.

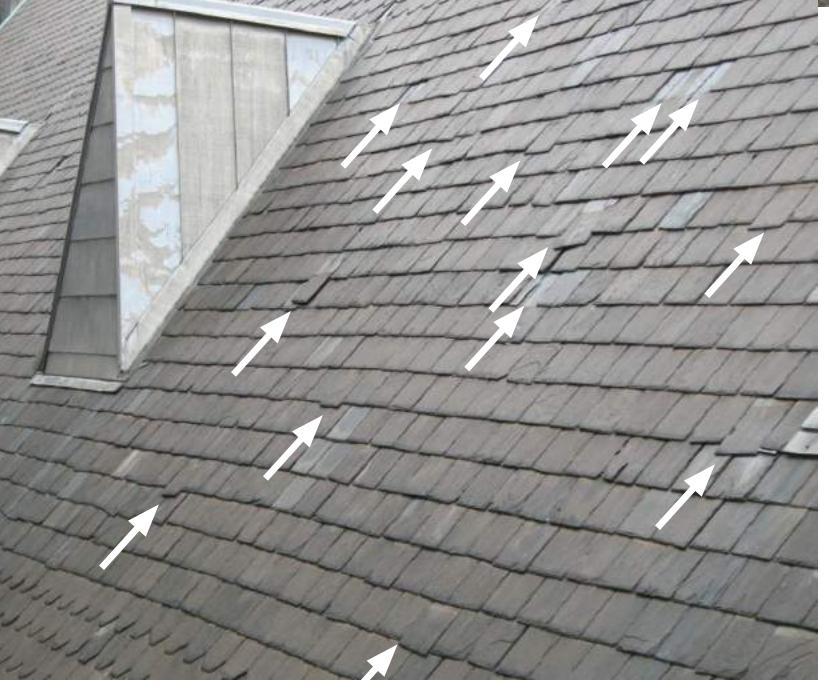
Figure 12: As a result of the corroded nails shown in Figure 11, numerous slates on this Peach Bottom slate roof had slid out of position.

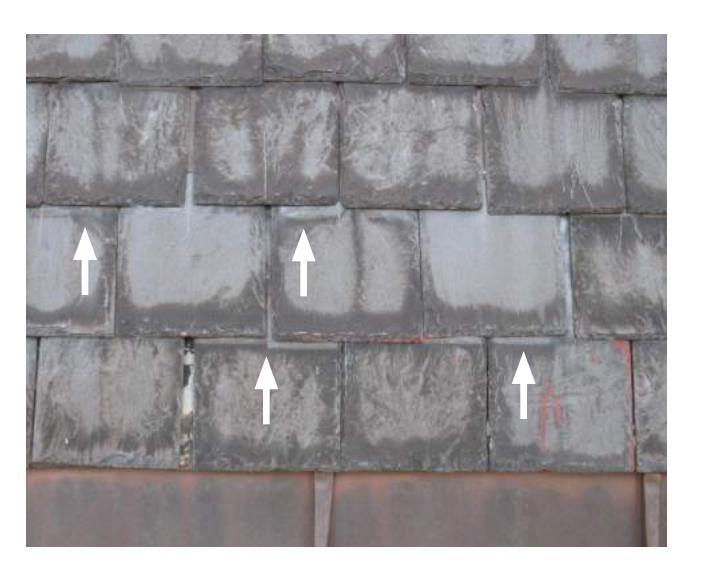
With longer-lived slates such as Peach Bottom and Buckingham, it is possible for the nails to have failed due to poor selection, while the slate shingles themselves still have decades of service life remaining. In such cases, salvage and reinstallation of the slate shingles can be considered. If this course of action is selected, the slate should be re-laid using the same, or less, exposure as the existing to mitigate the visual impact of ghost lines, indicating the original exposure of the slate, on the reinstalled roof (Figure 13).⁶ Keep in mind that exposure and headlap are inversely related and that the change in headlap will always be two times the change in exposure. Increasing headlap beyond that required is acceptable (within limits, of course), whereas reducing headlap is not (see Figure 13).

Figure 13: Example of ghost lines on the exposed face of slates that have been reinstalled above a new standing seam copper roof. In the case of partial removal, salvage, and reinstallation of slate shingles it is also important to match the original exposure of the slate in order to maintain the intended headlap. In this case, the extra 1/2" of exposure resulted in the loss of a full inch of headlap; from a 3" headlap down to a 2" headlap. Two-inch headlap is insufficient for the 9:12 slope of the roof. Note too, the lack of patina formation in that portion of the copper roofing located along the drip line of the slate shingles.

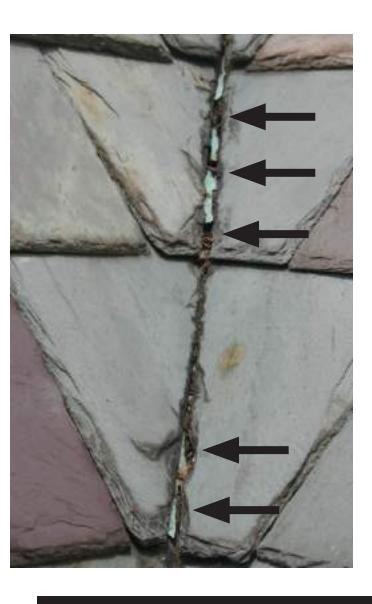
Figure 14: Despite the presence of debris, wear holes are still quite evident along the centerline of these 65-yearold copper closed valley flashings. Figure 15: A slate shingle was removed in order to get a better look at the condition of the base flashings located along this gable end wall.

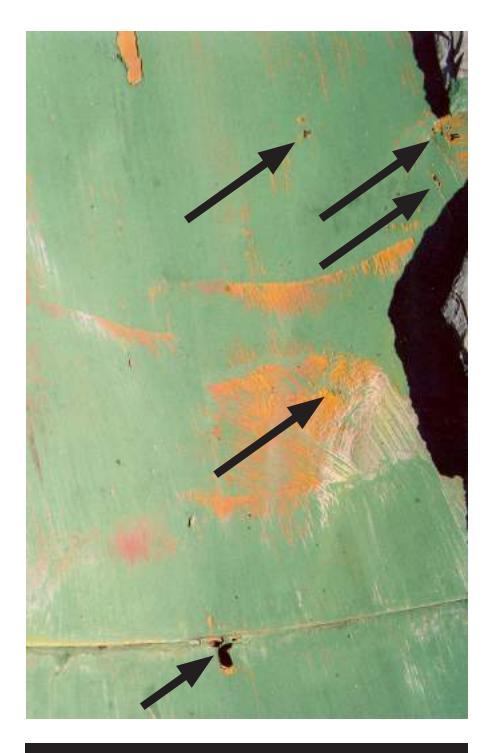
In areas of concentrated water flows, copper flashings often turn a golden orange color before they actually wear through (Figure 16). This color is an indication that the copper is paper thin (to the point where one can easily push a finger through the material) and in need of replacement. This condition must be distinguished from the duller copper color that indicates a patina is not being formed due to frequent, often concentrated, water flows, but where the copper still has sufficient thickness, as can be seen below the drip line of the slates in Figure 13. Other conditions to look for include

Figure 16: Painted copper open valley flashing. The golden orange color indicates that the copper is paper thin. Arrows point to where the copper has already worn through.

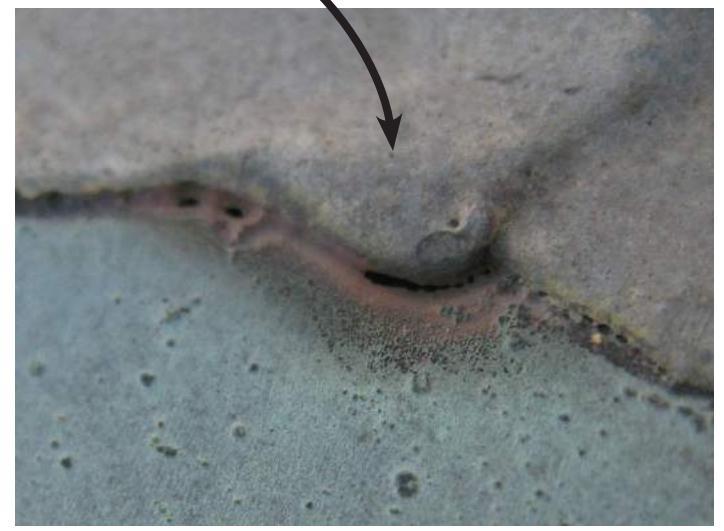
Figure 17: Corrosion holes along a soldered seam in a copper flashing.

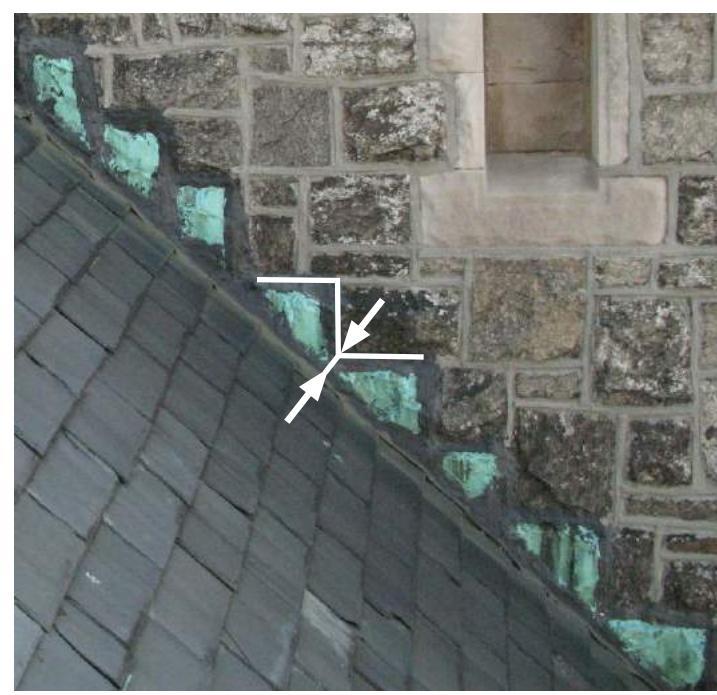
Figure 18: On the left, base flashings, which are interwoven with each course of slate, are consistently spaced, but counterflashings are too short and do not provide sufficient cover over the base flashings. On the right, base flashings, although concealed, are known to be too short due to inappropriate layout of the stepped counterflashings. Extending the counterflashings to the right would have allowed for a full 4" vertical leg in the base flashings instead of the 1-3/4" to 2" that was achieved (see double-arrowed line).

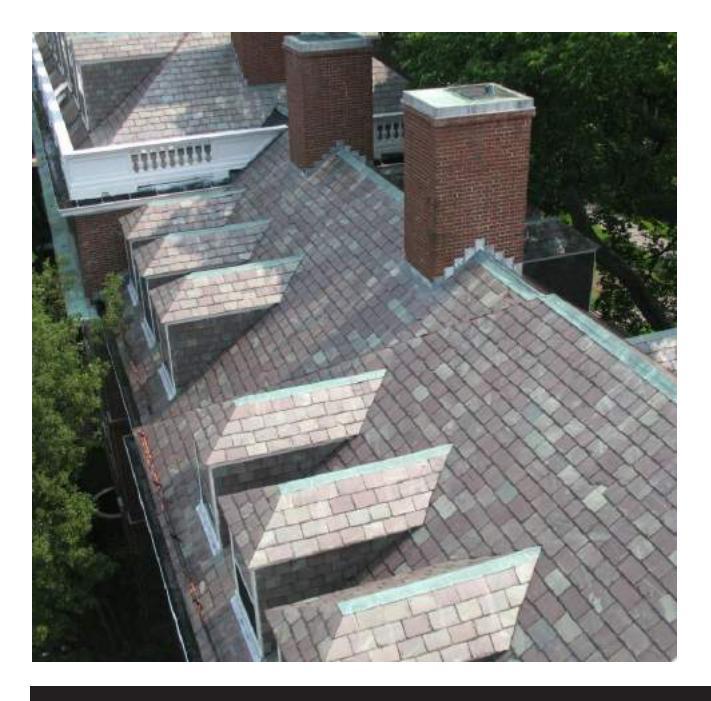
Whether or not the poor condition of a roof's flashings merits replacement of the entire roof requires professional judgment and is dependent on several factors. If, for example, the slate and slating nails are in good condition and have an expected remaining service life of 20 or more years, and the roof plan is fairly straightforward (i.e., few changes in plane and a limited number of dormers, chimneys, and skylights all things that require flashings), then a flashing replacement project may be most practical. If the slate only has an expected remaining service life of ten years, and/or the roof is "cut up" (i.e., containing many valleys, dormers, chimneys, and penetrations), it may be that by the time enough slate is removed to replace all of the deteriorated flashings it is simply more practical to replace the entire roof (Figure 19).

Figure 19: The slating nails on this roof were found to be in good condition and the slate possessing a remaining service life of several decades. All flashings and gutters, however, were deteriorated. Given the quantity of slate that would have to be removed to replace all the flashings and gutters, the owner decided to replace the slate as well.
