# ALL WAGNER ROOFING RESTORES HANDS FIVE ROOF SYSTEMS ON ON THE U.S. NAVAL ACADEMY'S ROOF MAHAN HALL DECK

BY CHRYSTINE ELLE HANUS

Reprinted with permission from *PROFESSIONAL ROOFING* magazine.  
December 2013 © by the National Roofing Contractors Association.

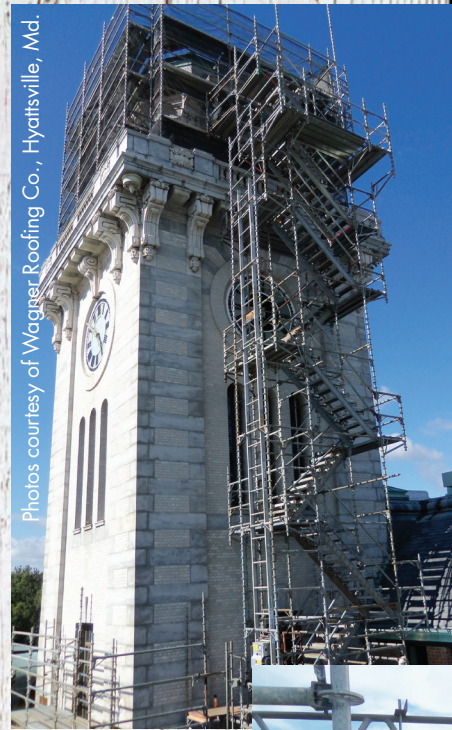
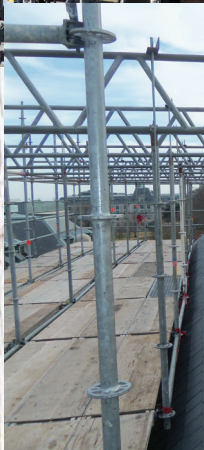
Top to bottom: A stair tower was installed for access and egress; new decorative copper flashing at the intersection of the slate mansard and flat-seam copper roofs

Per NAVFAC Engineering Manual 385, a stair tower also was installed for access and egress and strategically set where it could be reached in either direction but not farther than 75 feet from the farthest point of other access and egress points.

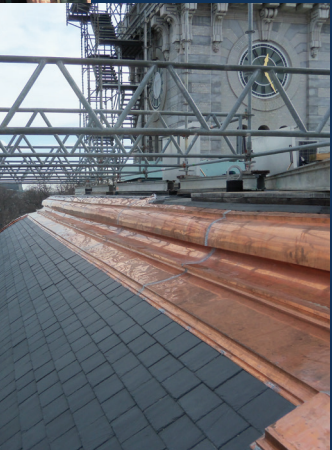
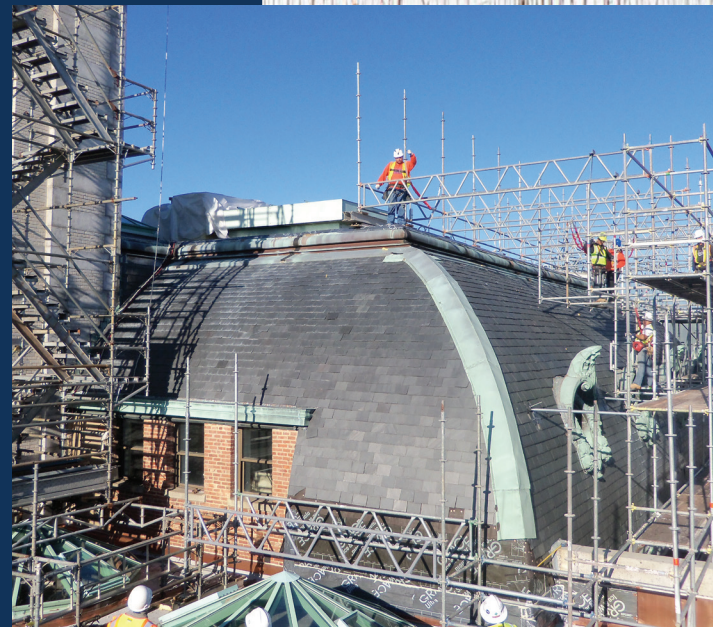
View of multiple roofs and details, including mansard slate, suspended scaffolding, hip metal and dormers

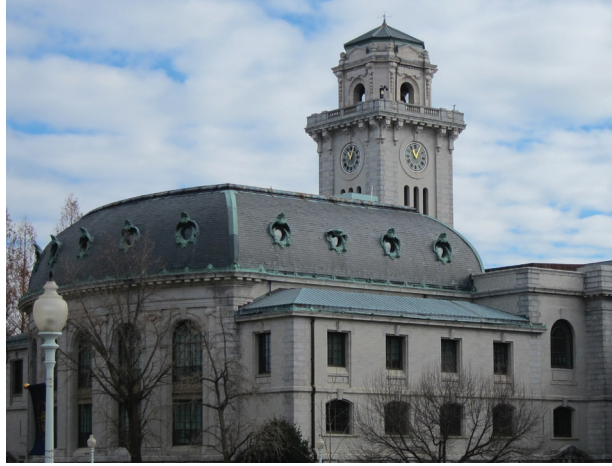
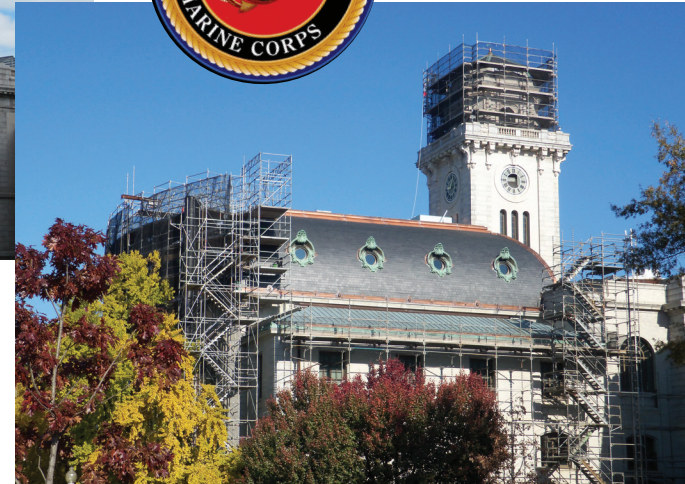
Left to right: Mahan Hall's southwest elevation before replacement; Mahan Hall and the clock tower under construction

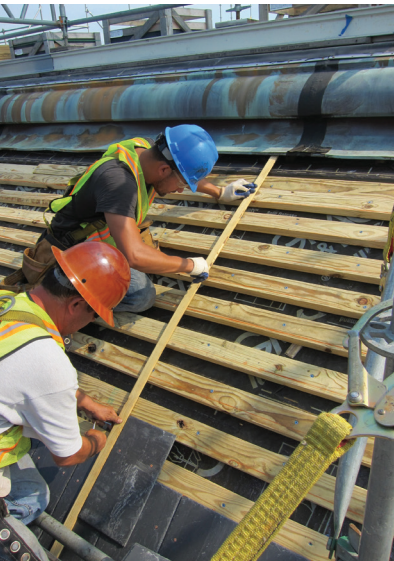
Slate on the mansard roof was installed onto wood nailers, which were preplanned and laid out so the nail holes for the slate aligned with a nailer.

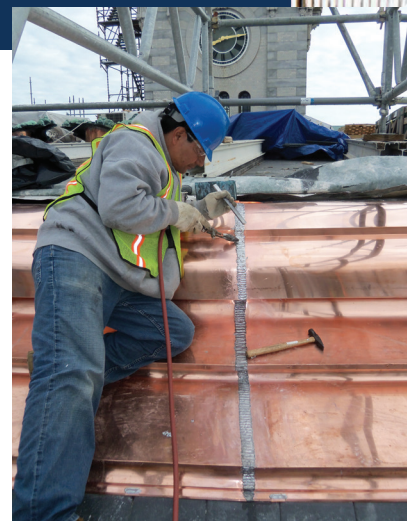
New copper cornice being installed

Once the slate and dormers were installed, Wagner Roofing's sheet metal department fabricated and installed the 20-ounce copper radial hip cap and two-piece bull-nose transition cornice/apron along the top of the mansard. Both details were duplicated to exact dimensions but were installed
