# ROOFING “OLD RED”

## CMR CONSTRUCTION AND ROOFING RESTORES THE ROOF ON A DALLAS MUSEUM

BY CHRYSTINE ELLE HANUS

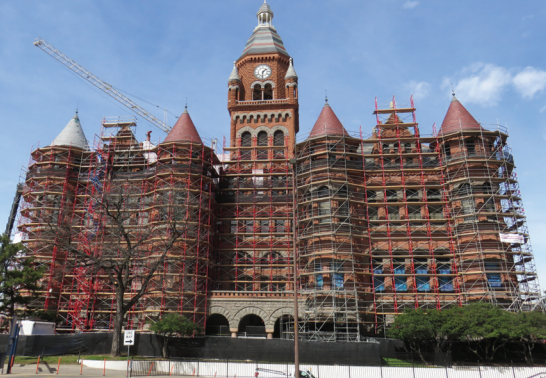
Workers erected scaffolding around the entire building and positioned hoists on the east and west sides.

Accordingly, in late 2018, workers erected scaffolding around the entire building. BETA MAX Hoists were positioned on the building's east and west sides to raise materials and tools to the main working level. From there, workers assembled trash chutes to remove debris. The city required all sidewalks to remain open, so workers extended the scaffolding across the sidewalks and down to trailers parked in the metered parking spots adjacent to the building.

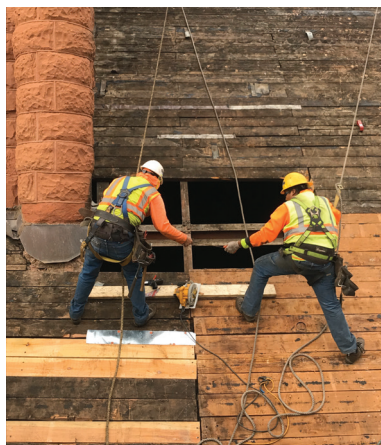
Crew members replaced more than 7,500 linear feet of customized sheathing.

CMR Construction and Roofing workers used powder-actuated fasteners to attach the new sheathing boards to the steel rafters.

“After we found pins that were long and thick enough to penetrate the steel, the attachment process went smoothly,” Soule says. “Our crew replaced more than 7,500 linear feet of 2- by 7½-inch boards.”

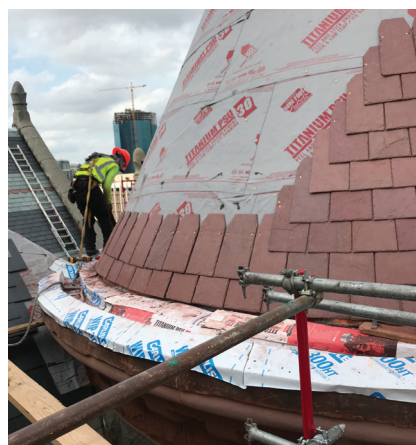
The red slate for the project took about 22 weeks to obtain, so it was shipped in small shipments as it was produced during an eight-month period.

“As the only viable source of quality red slate in the U.S., Hilltop Slate supplied the red scalloped slate and the red slate for the turrets,” Soule says. “Green and black slate are relatively available from North Country Slate with a three- to four-week delivery lead time, but red slate generally takes 22 weeks or longer to obtain and is subject to weather delays. So we received the red slate in small shipments during an eight-month period. Planning the work to accommodate the slow trickle of material was difficult.”

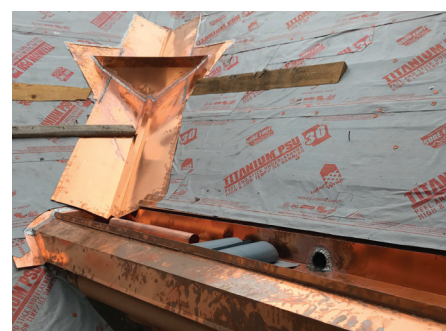
Craftsmen created more than 700 linear feet of copper valleys, 1,900 linear feet of copper flashing and 1,500 linear feet of custom copper gutters.

Workers installed new copper gutters over the underlayment and riveted and soldered all joints to the existing internal drainage components. CMR Construction and Roofing craftsmen formed the gutters to fit around columns and other difficult details, including a radius gutter around the turrets.

“We decided to eliminate as many soldered joints from the radius gutter as possible, so the average distance between joints increased from 12 to 36 inches,” Soule explains. “This was accomplished by cutting curved sections of copper instead of short pieces to dramatically reduce wasting copper material, reducing the number of joints and potential future failure points.”

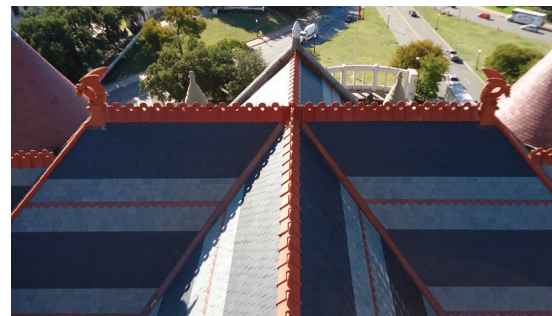
Workers installed red, green and black slate in patterns to match the original roof design.

Workers installed the green, black and red slate in patterns to match the original roof design.

“We painstakingly laid out the color bands around the entire building, including the rafters that were many times several inches out of square from end to end,” Soule says. “We attached the slates with two copper nails each, which were difficult to drive into true 2-inch-thick roof sheathing.”
