Roofing American History

The Durable Slate Company helps restore the dome on Maryland's state capitol

by Chrystine Elle Hanus

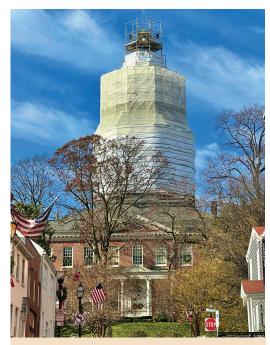
New double-locked, standing-seam copper panels on the acorn base

At the top of the lantern dome is an acorn base that originally consisted of double-locked, standing-seam, lead-coated copper.

"The double-locked seams didn't have enough minimum lap in the locks, creating potential sources for leaks," Collins says. "We replaced the existing apron with new double-locked, standing-seam panels that were stretched to match the dome's radius."
