29 PRESERVATION BRIEFS

The Repair, Replacement, and Maintenance of Historic Slate Roofs

U.S. Department of the Interior
National Park Service
Cultural Resources
Heritage Preservation Services

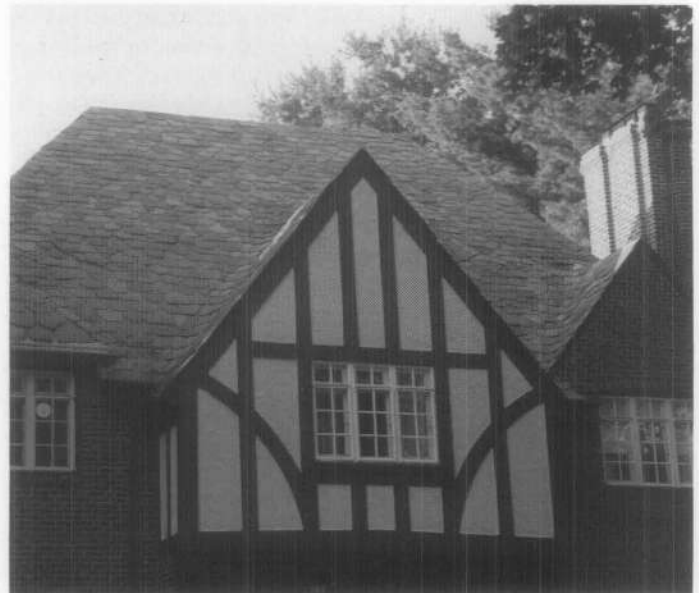
Figure 2. The quaint character of this Tudor style residence is derived, in part, from its textural roof.

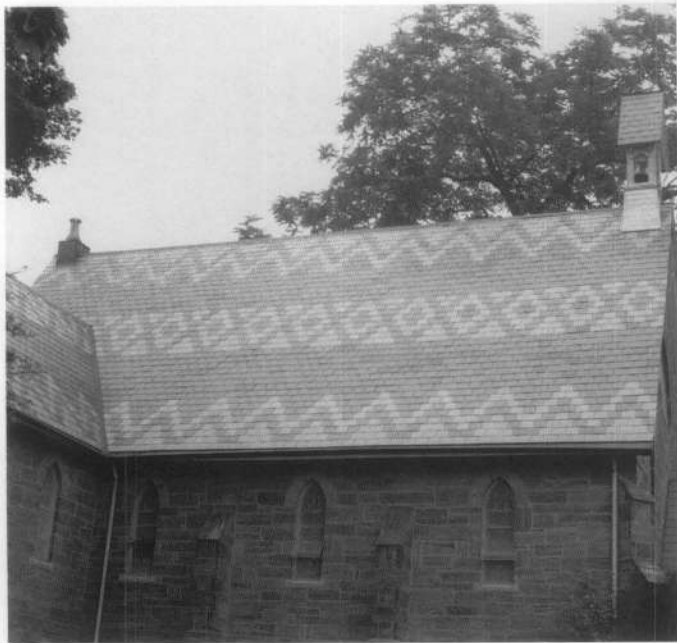
Figure 3. A sawtooth geometric design composed of red, green, and black slates makes this roof the most visually important feature of the building.

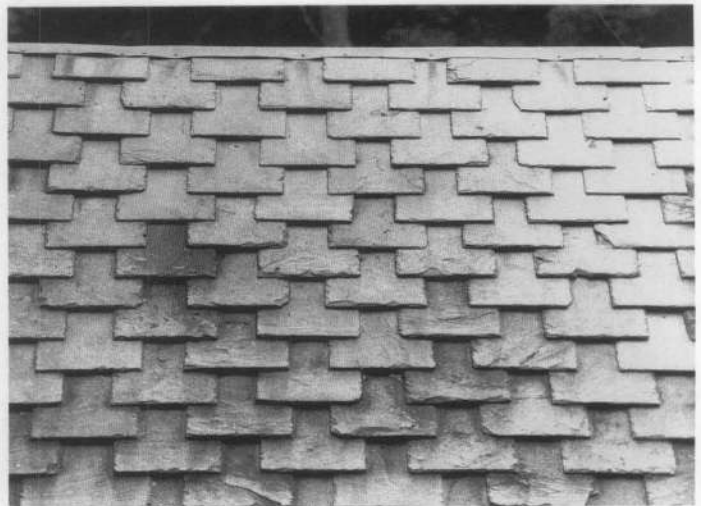
Figure 4. Widely spaced open slating was often used on utilitarian structures where ventilation was desirable. It provided an interesting texture and visual pattern to often plain structures.

Historically, three types of slate roofing—standard, textural, and graduated—were available according to the architectural effect desired. Standard grade slate roofs were most common. These are characterized by their uniform appearance, being composed of slates approximately 3/16" (0.5cm) thick, of consistent length and width, and having a smooth cleavage surface. Thirty different standard sizes were available, ranging from 10" (25cm) × 6" to 24" × 14" (15cm × 61cm × 35cm). The slates were laid to break joints and typically had square ends and uniform color and exposure. Patterned and polychromatic roofs were created by laying standard slates of different colors and shapes on the roof in such a way as to create sunbursts, flowers, sawtooth and geometric designs, and even initials and dates (Figure 3). On utilitarian structures, such as barns and sheds, large gaps were sometimes left between each slate within a given course to reduce material and installation costs and provide added ventilation for the interior (Figure 4).

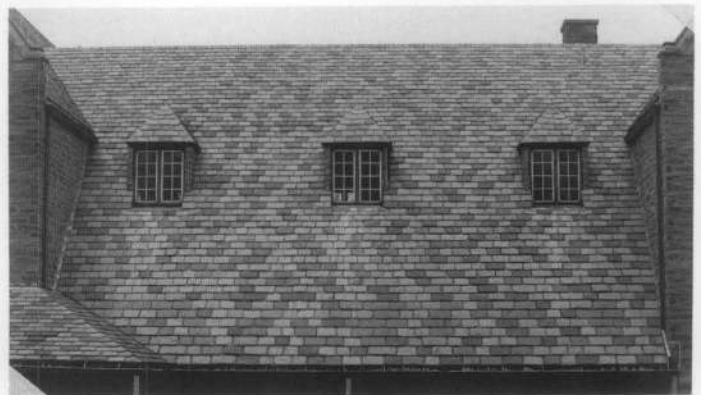
Figure 5. This graduated slate roof is composed of large, thick slates at the eave which are reduced in size and thickness as the slating progresses to the ridge.

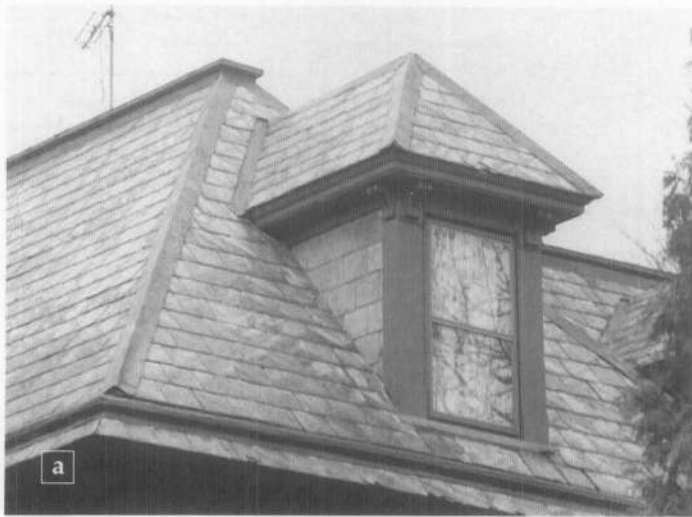
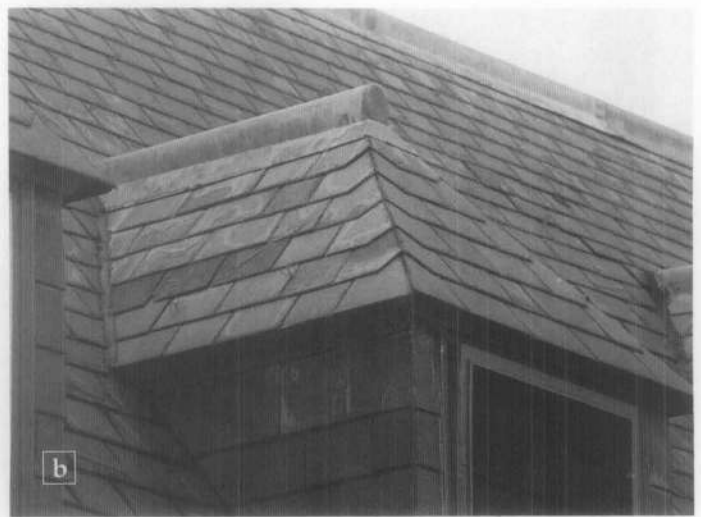
Figure 6. Hips are formed at the external angle of two roofing slopes. In (a), the hips at both the roof and the dormer are covered with metal. Note also the open valley and the built-in gutter. In (b), the dormer hip slates have been laid in a fantail pattern to help shed water. Note also the metal ridge cap.

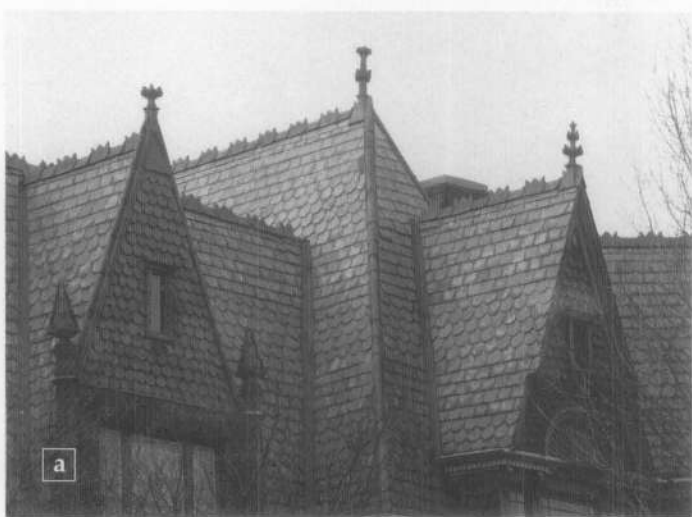
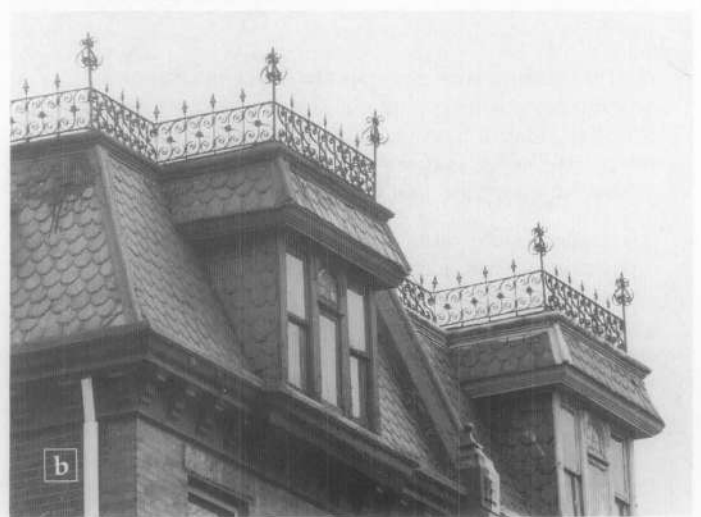
Figure 7. Ridge caps and cresting can be elaborate. Ridges are formed at the long horizontal juncture of two roofing slopes and capping protects this joint from moisture. In (a), a terra cotta capping with a decorative profile complements the finial over the various roof peaks. In (b), the mansard roof has a decorative iron cresting at the break between the lower and the upper roof slopes.

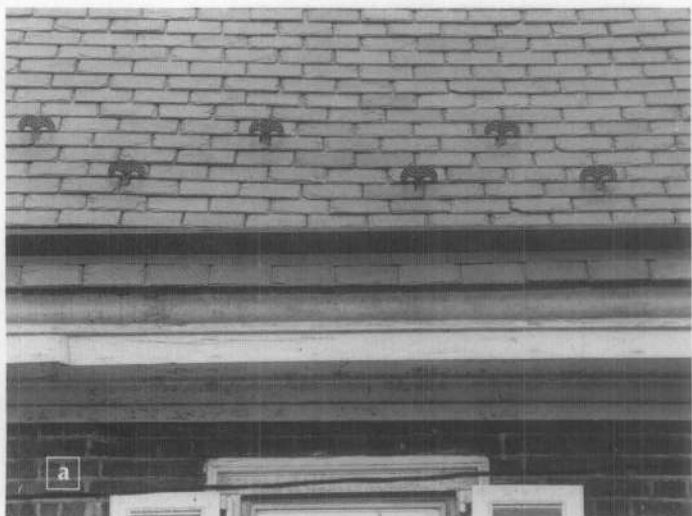
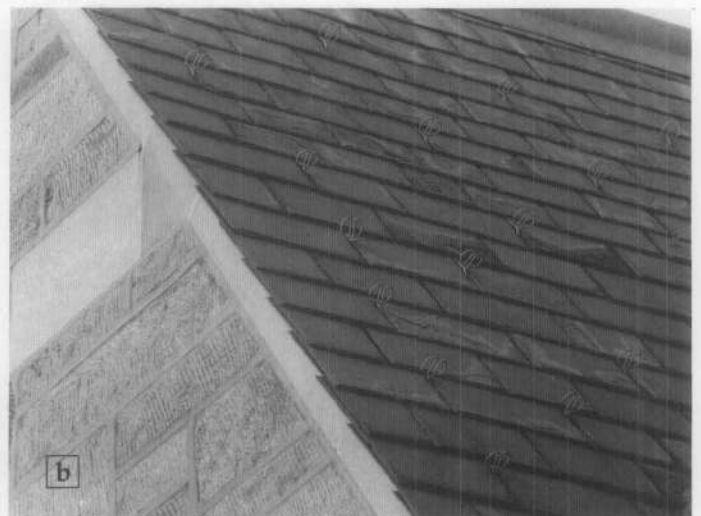
Figure 8. Eave details include snow guards, snow boards, gutter treatments. Snow guards are generally used in areas where ice and snow accumulate to avoid dangerous slides from the roof. In (a) the snow guards are set in two staggered rows above a pole gutter. In (b), the copper wire snow guards are set more frequently up a very steep gable.

Detailing at the hips, ridges and valleys provided added opportunity to ornament a slate roof. Hips and ridges can be fashioned out of slate according to various traditional schemes whereby the slates are cut and overlapped to produce a watertight joint of the desired artistic effect. Traditional slate ridge details are the saddle ridge, strip saddle ridge, and comb ridge, and for hips, the saddle hip, mitered hip, Boston hip, and fantail hip (Figure 6). A more linear effect was achieved by covering the ridges and hips with flashing called "cresting" or "ridge roll" formed out of sheet metal, terra cotta, or even slate (Figure 7). Snow guards, snow boards, and various types of gutter and rake treatments also contributed to the character of historic slate roofs (Figure 8).

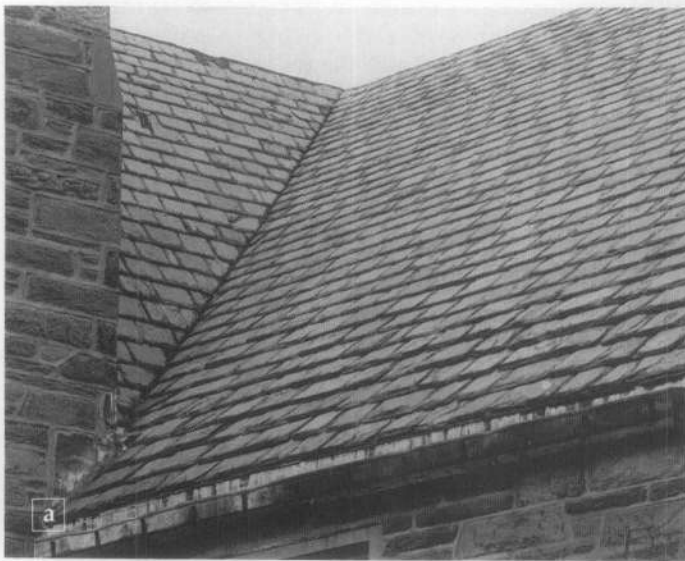
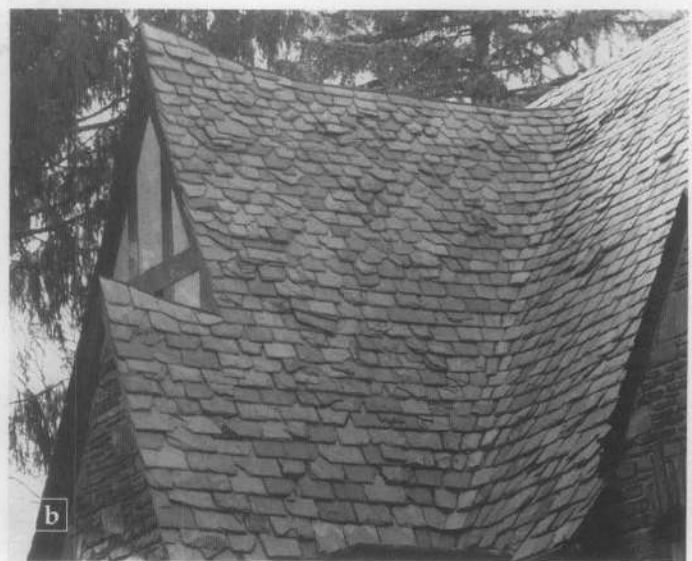
Figure 9. Valleys are formed at the internal angle of two roofing slopes. Flashing is often placed under the slate to increase moisture protect at this vulnerable joint. Shown in (a) is a closed valley where the slates are held tight to the valley line. (b) illustrates of a round valley where the transition between the two slopes is a continuous curve. It requires careful workmanship and an experienced roofer.

Two types of valleys were traditionally employed, the open valley and the closed valley. The open valley is lined with metal over which slates lap only at the sides. Closed valleys are covered with slate and have either a continuous metal lining or metal flashing built in with each course. Open valleys are easier to install and maintain, and are generally more watertight than closed valleys. Round valleys are a type of closed valley with a concave rather than V-shaped section (Figure 9). Given the broader sweep of the round valley, it was not uncommon for roofers to interweave asphalt saturated felts rather than copper sheet in the coursing in order to cut costs.

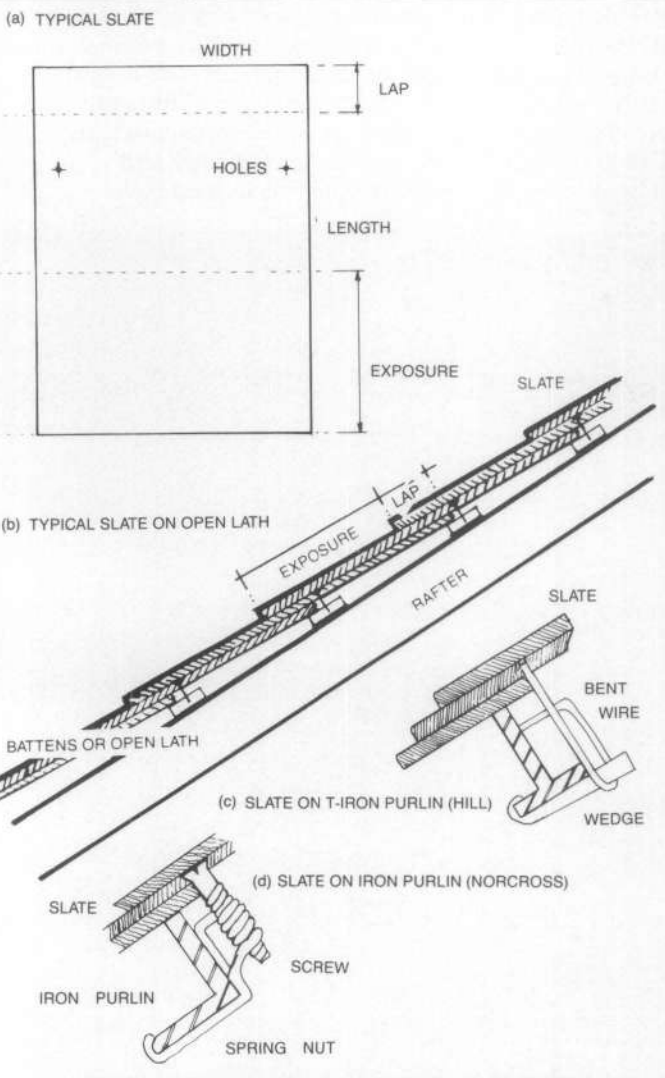
Figure 10. (a) shows a typical slate; exposure may be calculated by subtracting the headlap from the total length of the slate and dividing by two. Slates were typically nailed either to closed wooden decking or to open laths (b). In the late 19th century, with the concern for fireproof construction, special fasteners were developed to secure slate to steel purlins (c) 1881 patent to James G. Hill; (d) 1889 patent to Orlando W. Norcross).

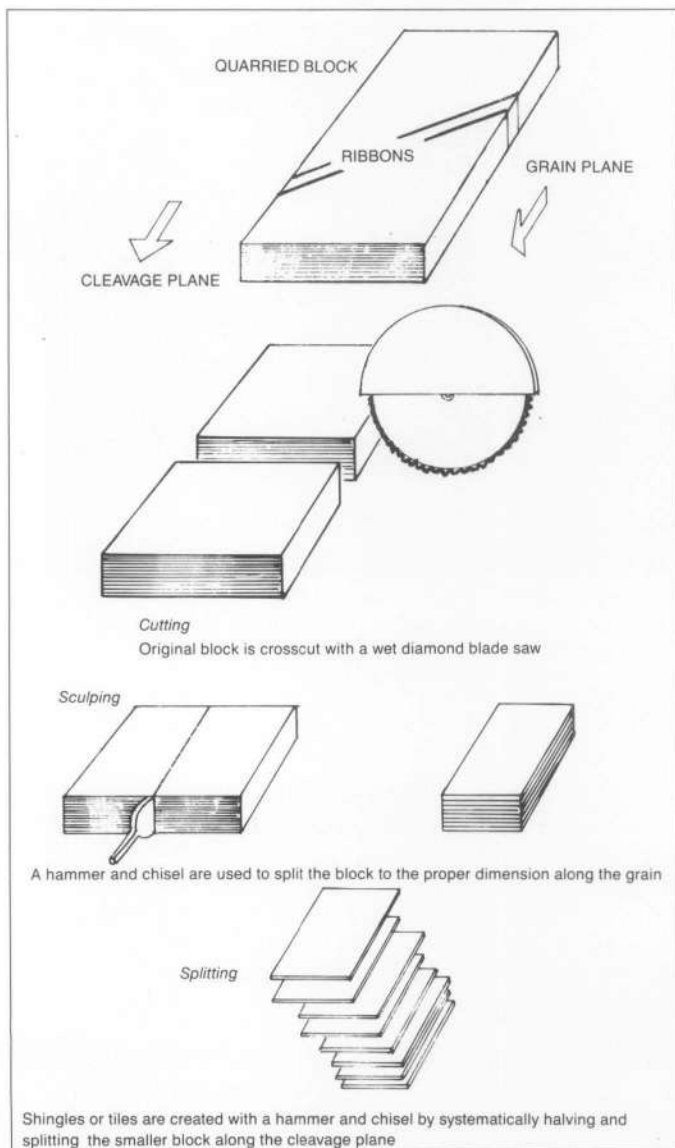
Figure 11. Slate roofing tiles or shingles are still manufactured using traditional methods brought to this country by Welsh immigrants in the nineteenth century. Shown above are the first 3 steps of cutting, sculping and splitting. Once the rough slate tile is made it is trimmed and punched for holes.

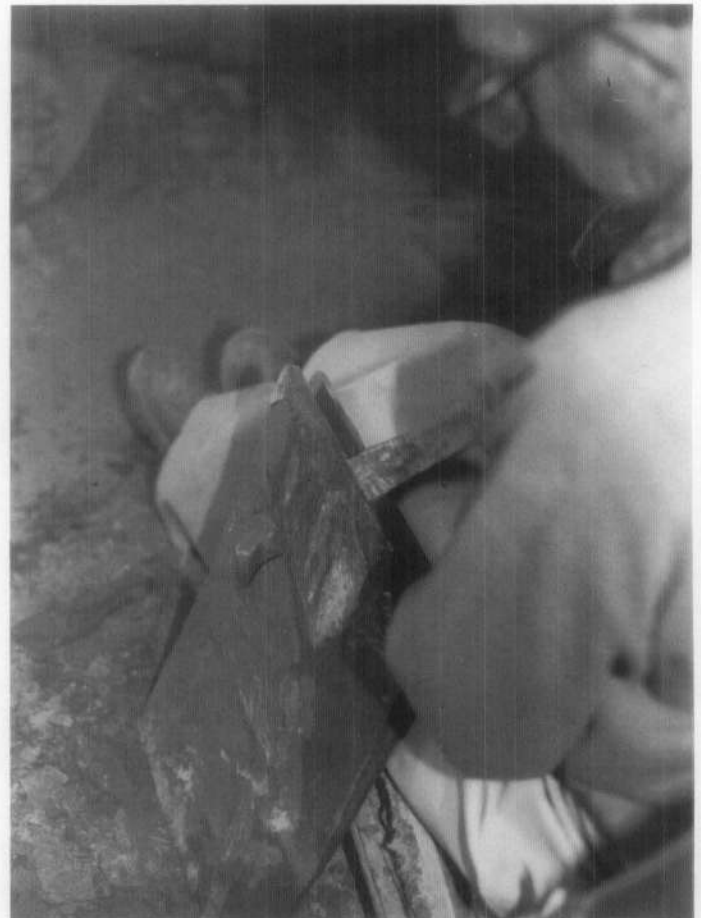
Figure 12. In the splitting area, the slightly oversized blocks are split along their cleavage planes. The splitter's tools consist of a wooden mallet and splitting chisels. The process of halving the split portions is repeated until a tile or shingle of appropriate thinness is obtained.

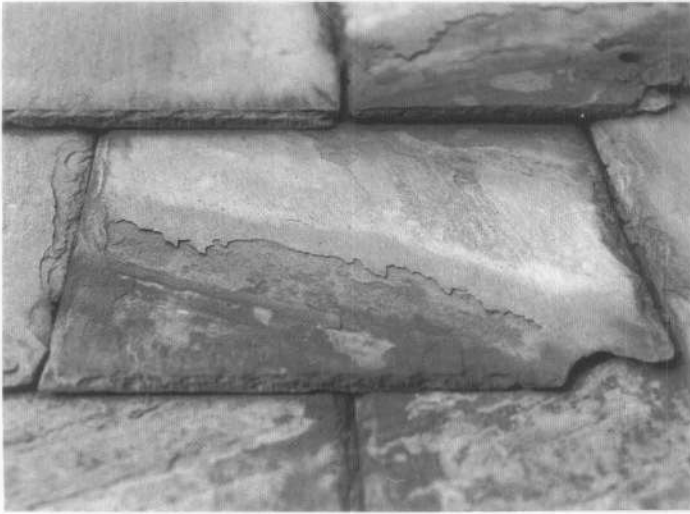
Figure 13. Paper thin lamination can be seen flaking off of this weathered, 120 year piece of Pennsylvania Hard-Vein slate.

The natural weathering of roofing slate manifests itself as a slow process of chipping and scaling along the cleavage planes (Figure 13). Paper thin laminations flake off the surface of the slate and the slate becomes soft and spongy as the inner layers begin to come apart, or delaminate. The nature of the sound given off by a slate when tapped with one's knuckles or slating hammer is a fair indication of its condition. High-grade slate, when poised upon the fingertips and struck, will emit a clear, solid sound. Severely weathered slates are much less sonorous, and give off a dull thud when tapped.

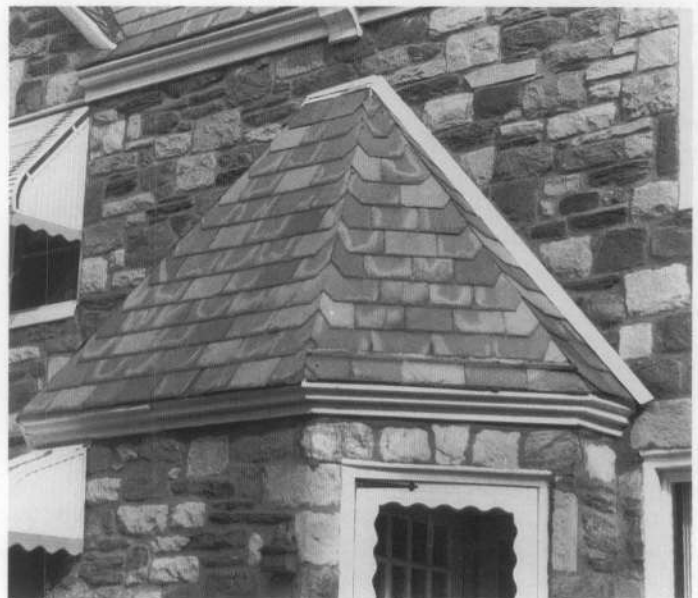
Figure 14. The white blotches on these Pennsylvania Soft-Vein slates indicate areas where gypsum is leaching out onto the surface of the slates.

The weathering of slate is chiefly due to mineral impurities (primarily calcite and iron sulfides) in the slate which, in concert with alternating wet/dry and hot/cold cycles, react to form gypsum (Figure 14). Because gypsum

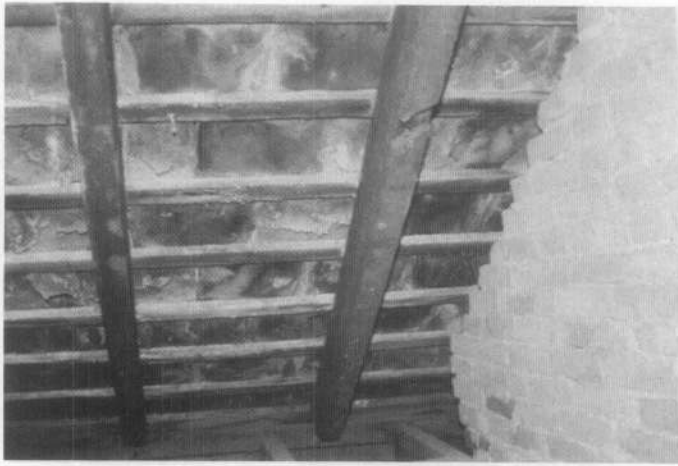
Figure 15. View of the underside of slates laid on open sheathing shows that delamination and flaking is just as bad or worse on the underside of slates as on the exposed surface. This is why most slates cannot be flipped over for reuse.

molecules take up about twice as much volume as calcite molecules, internal stresses result from the reaction, causing the slate to delaminate. This type of deterioration is as prominent on the underside of the roof as on the exposed surface due to the leaching and subsequent concentration of gypsum in this area (Figure 15). Consequently, deteriorated roofing slates typically cannot be flipped over and re-used.

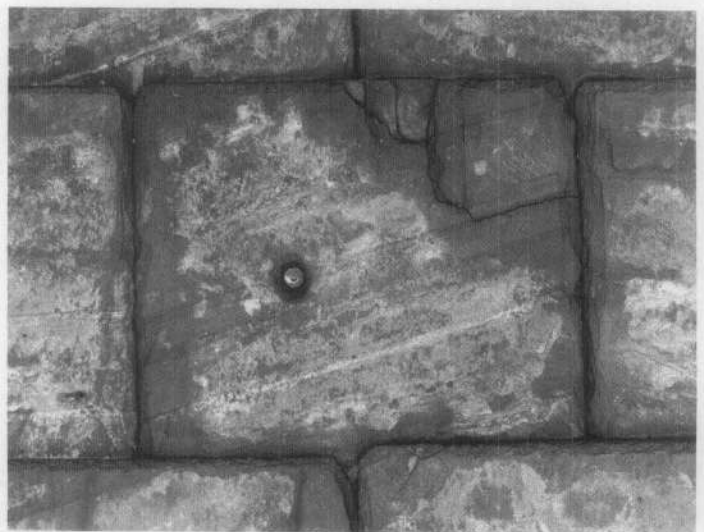
Figure 16. Detail view of a slate which has been punctured by the head of a nail used to secure the slate in the course below. Likely, the nail was not hammered in far enough when originally installed.

Installation problems often involve the improper nailing and lapping of slates. The nailing of slates differs from that of other roofing materials. Slate nails should not be driven tight as is the case with asphalt and wood shingles. Rather, they should be set such that the slate is permitted to hang freely on the nail shank. Nails driven too far will crack the slate and those left projecting will puncture the overlying slate (Figure 16). Nail heads left exposed accelerate roof deterioration by providing a point for water entry. Non-ferrous slater's nails, such as solid copper or stainless steel, should always be used since plain steel and galvanized nails will usually rust out long before the slate itself begins to deteriorate. The rusting of nineteenth century cut nails is a common cause of slate loss on historic roofs.

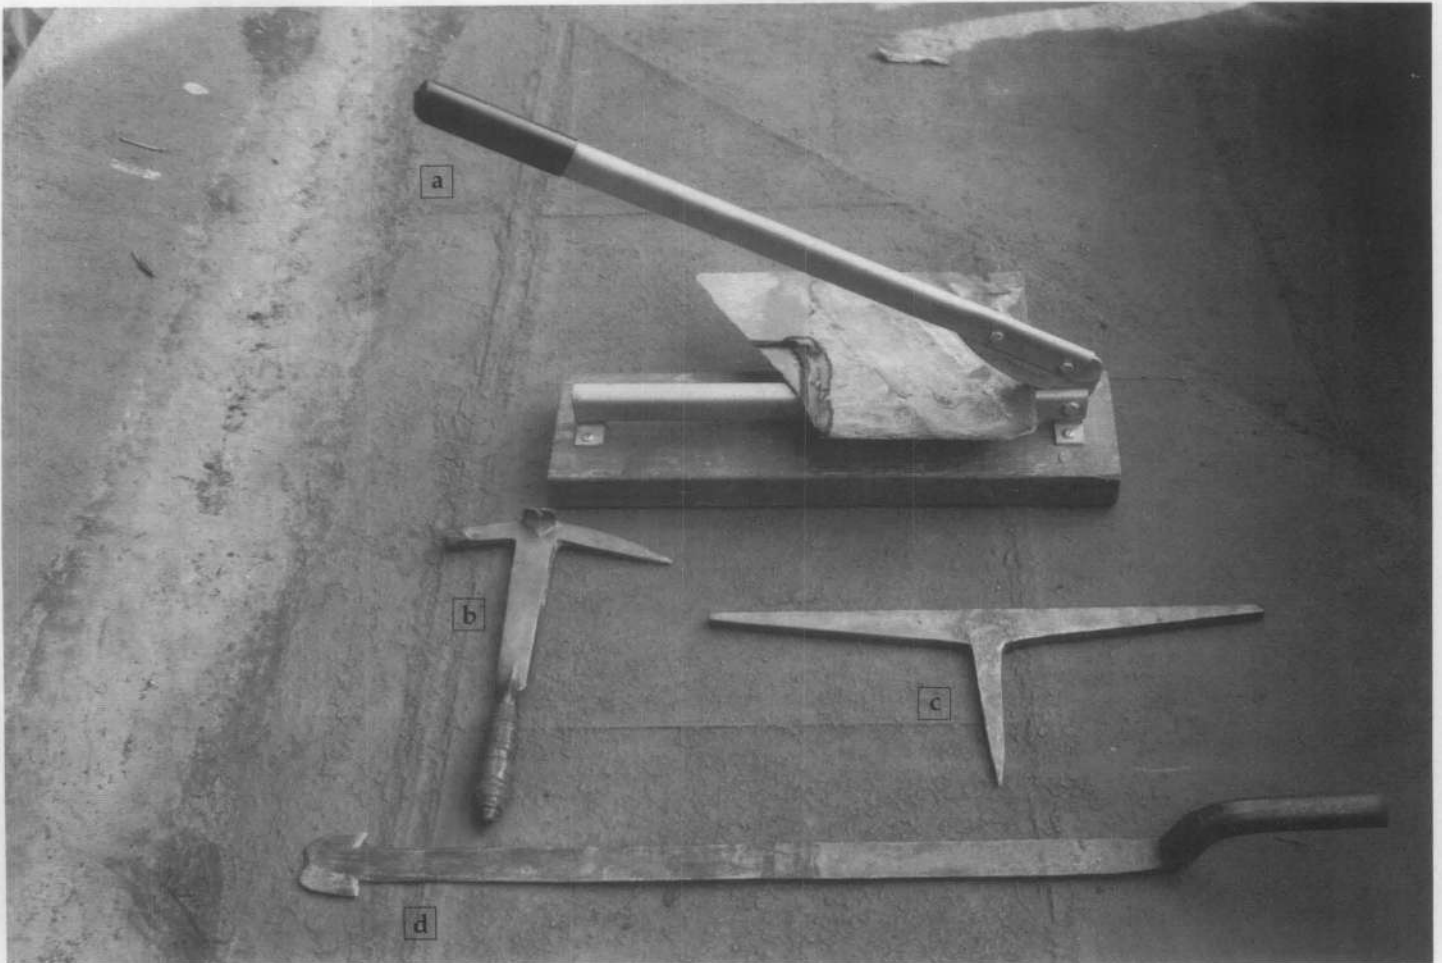
Figure 17. Slater's Tools. The cutter (a) is used to trim slate edges; the slate hammer (b) is used for hammering nails, trimming, cutting and punching holes in slates, and pulling roofing nails; the steak (c) is a T-shaped piece of iron upon which the slater places the edge of a slate to be trimmed; and the ripper (d) is slid under the slates to pull out the nails.

The ability to lay slate properly so as to produce a water-tight and aesthetically pleasing roof requires training, much practice, and the right tools (Figure 17). The

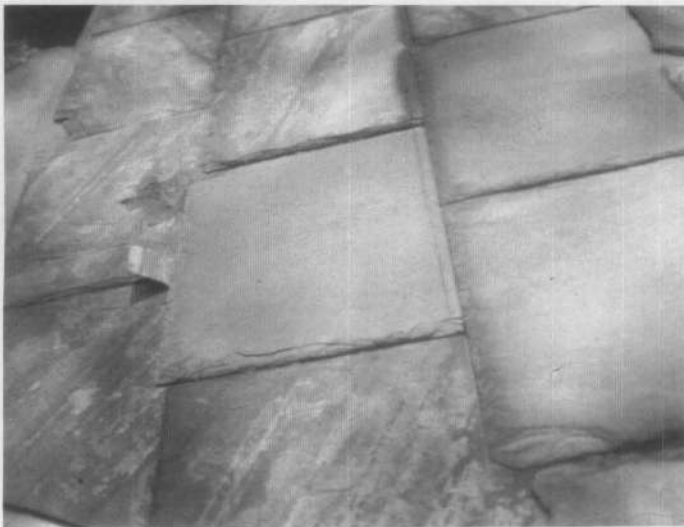
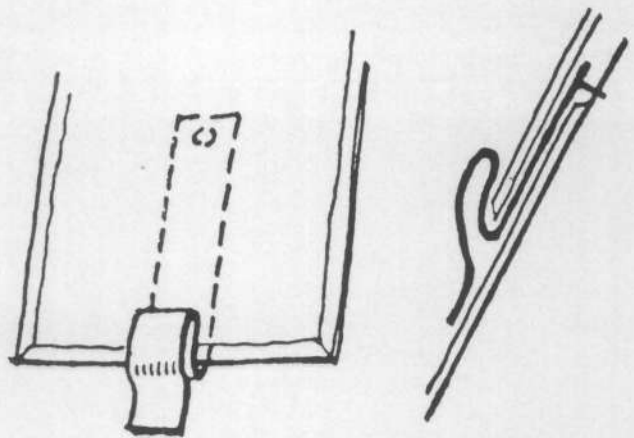
Figure 18. A method of securing replacement slates is shown. The copper strip is nailed to the roof sheathing just above the head of the slate in the course below. The replacement slate is then inserted and the copper tab folded over its tail. This type of repair is not recommended for northern climates where snow and ice can cause the copper tab to fold over, allowing the replacement slate to slide out of position as occurred here on the left.

Broken, cracked, and missing slates should be repaired promptly by an experienced slater in order to prevent water damage to interior finishes, accelerated deterioration of the roof and roof sheathing, and possible structural degradation to framing members (Figures 18 and 19).

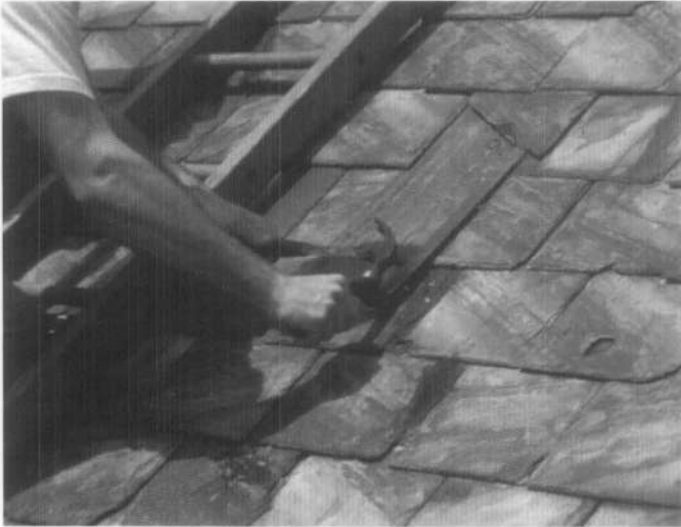
(a) A ripper is used to remove the nails from the deteriorated slate.

Figure 19. Above is a repair sequence for replacing a damaged slate.

The damaged slate is first removed by cutting or pulling out its nails with a ripper. If steel cut nails, rather than copper nails, were used in laying the roof, adjacent slates may be inadvertently damaged or displaced in the ripping process, and these, too, will have to be repaired. If the slate does not slide out by itself, the pointed end of the slate hammer can be punched into the slate and the slate dragged out. A new slate, or salvaged slate, which should match the size, shape, texture, and weathered color of the old slate, is then slid into place and held in position by one nail inserted through the vertical joint between the slates in the course above and approximately one inch below the tail of the slate two courses above. To prevent water penetration through the newly created nail hole, a piece of copper with a friction fit, measuring roughly 3" (7.5 cm) in width and 8" (20 cm) in length, is slid lengthwise under the joint between the two slates located directly above the new slate and over the nail. Alternate methods for securing the replacement slate include the use of metal hooks, clips, and straps that are bent over the tail end of the slate. The application of roofing mastic or sealants to damaged slates should *not* be considered a viable repair alternative because these materials, though effective at first, will eventually harden and crack, thereby allowing water to enter (Figure 20). Mastic also makes future repairs more difficult to execute, is unsightly, and, when applied to metal flashings, accelerates their corrosion.

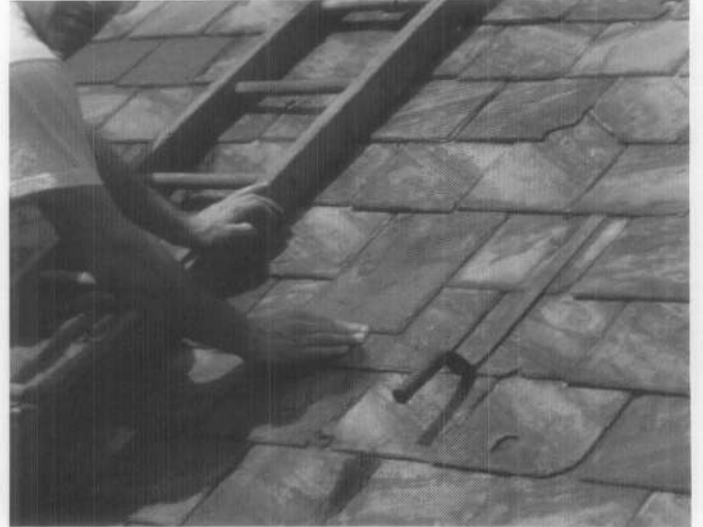
(b) A replacement slate is slid into place.

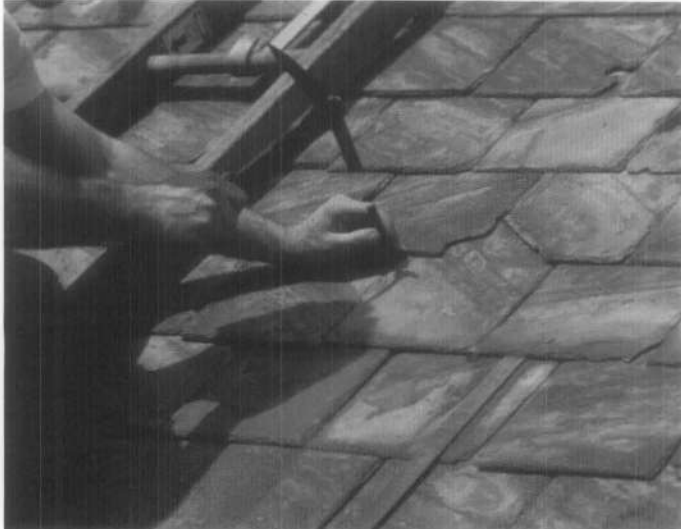
(c) A new slate is secured in place with a copper nail.

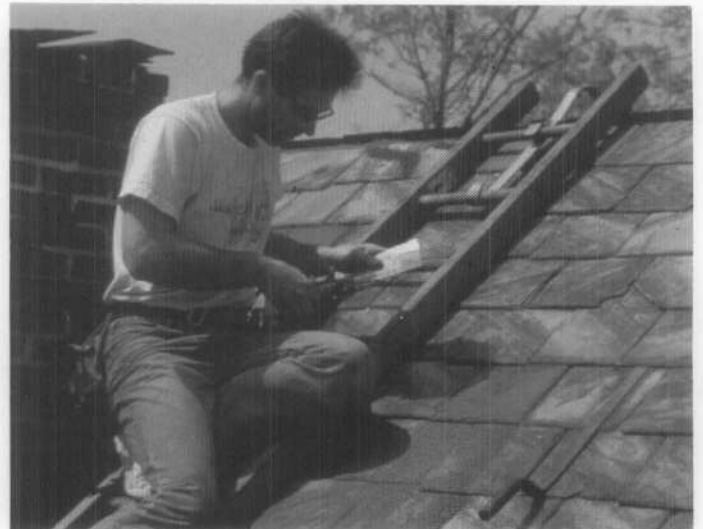
(d) A copper bib is formed to protect the newly created nail hole.

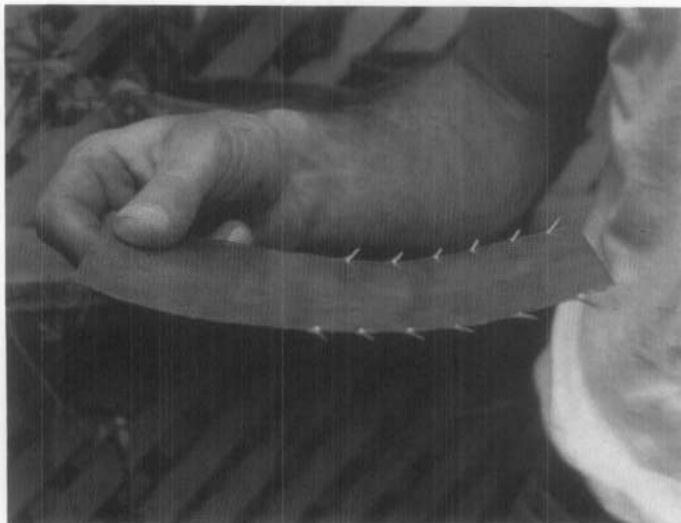
(e) The bib is cut along its edges and bent into a concave shape to create a friction fit.

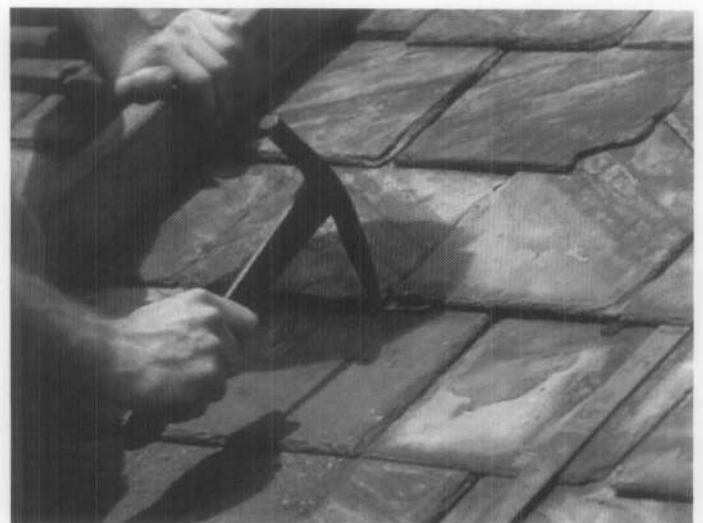
(f) The slate hammer is used to push the bib in place over the nail head.

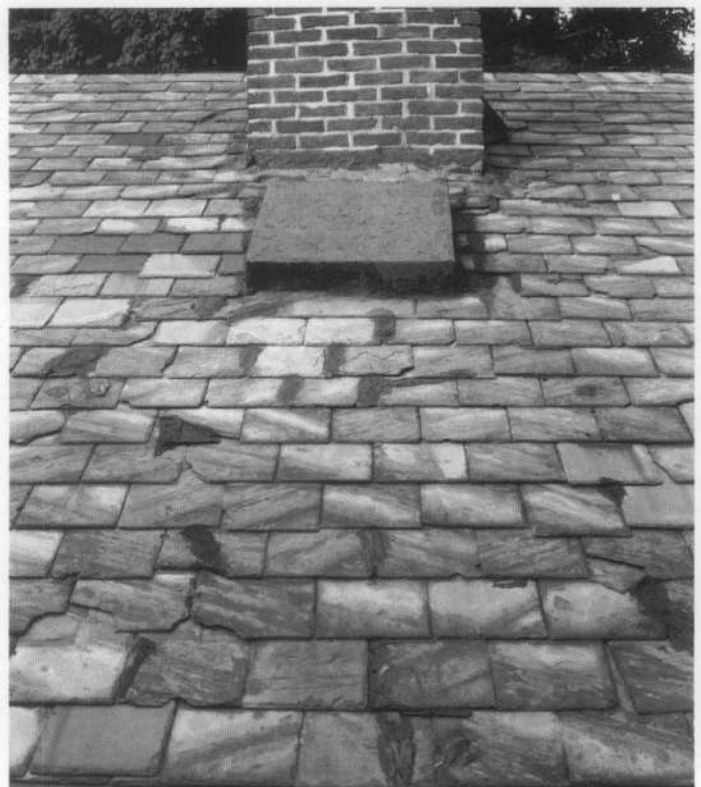
Figure 20. This roof has been poorly repaired numerous times in the past. The installation of mastic to seal out moisture has only exacerbated the problem. A timely repair and good maintenance could have extended the life of this roof.

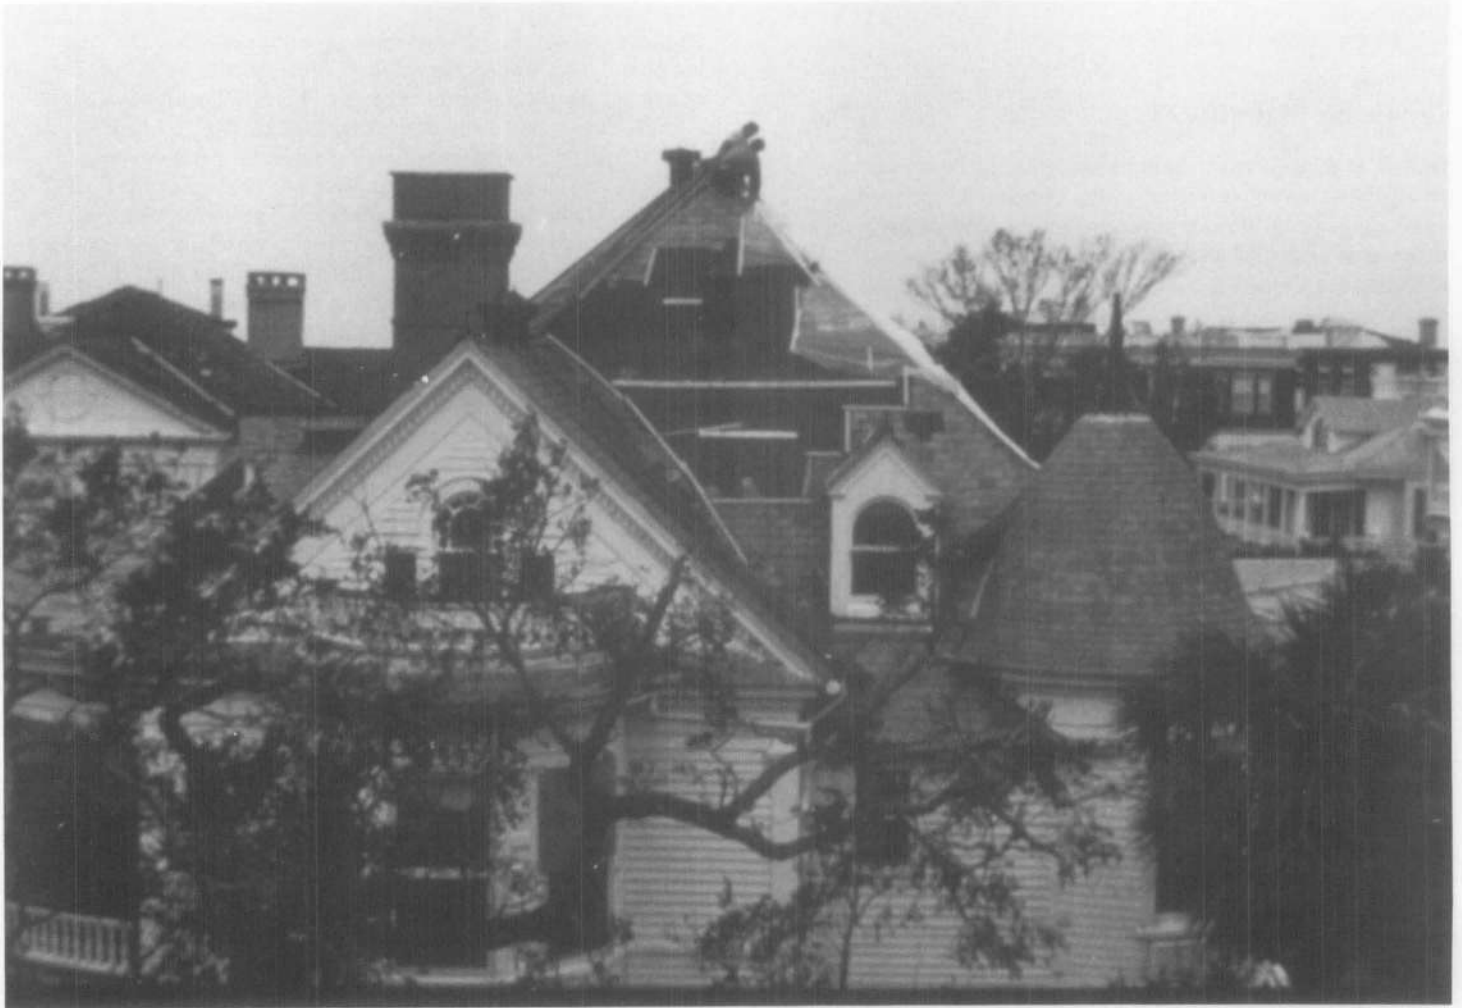
Figure 21. As a result of hurricanes and other disasters, it may be necessary to temporarily stabilize a roof until materials can be obtained and a qualified roofing contractor hired. Heavy roofing felt was stitched into this slate roof to stop moisture penetration until matching slate was obtained for repair. Significant slate roofs should not be stripped off and replaced with asphalt shingles. Photograph courtesy of the National Park Service.

In emergency situations, such as when severe hurricanes or tornadoes blow numerous slates off the roof, a temporary roof covering should be installed immediately after the storm to prevent further water damage to the interior of the building and to permit the drying out process to begin. Heavy gauge plastic and vinyl tarpaulins are often used for this purpose, though they are difficult to secure in place and can be blown off in high winds. Roll roofing, carefully stitched in to areas of the remaining roof, is a somewhat more functional solution that will allow sufficient time to document the existing roof conditions, plan repairs, and order materials (Figure 21).

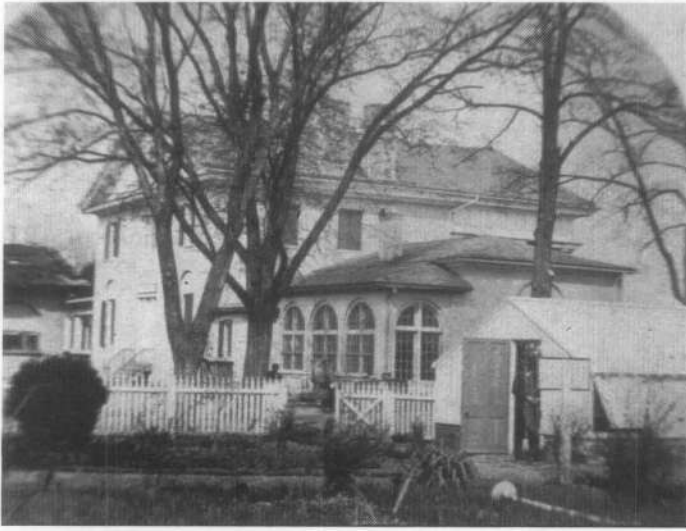
(a) Historic documentation was necessary to determine the historic configuration.

Figure 22. Installing a new roof involves more than just slate. Above is a sequence of views of the roof replacement at Arlington House. Photographs courtesy of the National Park Service. (Sequence continued on page 14.)

If repair is not possible and a new slate roof must be installed, it is important to remember that more than just the replacement of the slate is involved (Figure 22). The old slate should be removed to prevent overloading of the roof timbers. Stripping should be done in sections, with felt installed, to avoid exposing the entire sub-roof to the weather. In the process, rotted wood sheathing should be replaced and the roof timbers checked for signs of stress, including deflection, cracking, and twisting. If such conditions are found, a structural engineer experienced in working with older buildings should be consulted. Other repairs, such as chimney repointing, which may require access to the roof should be completed before the new roof is put on.

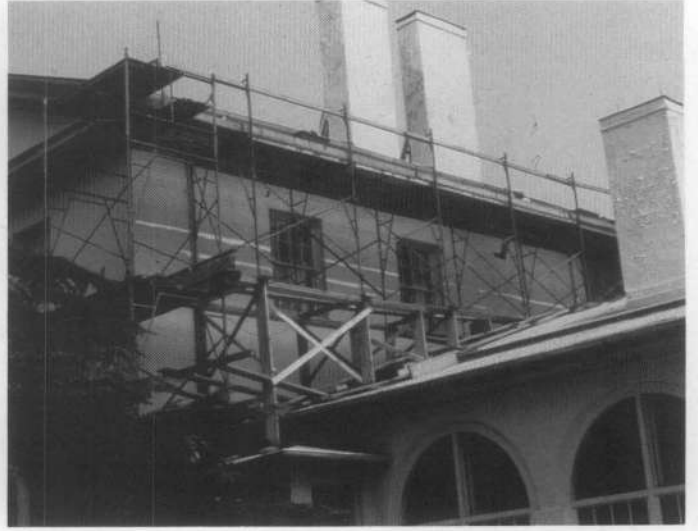
(b) Scaffolding was installed early to document existing conditions to determine extent of work.

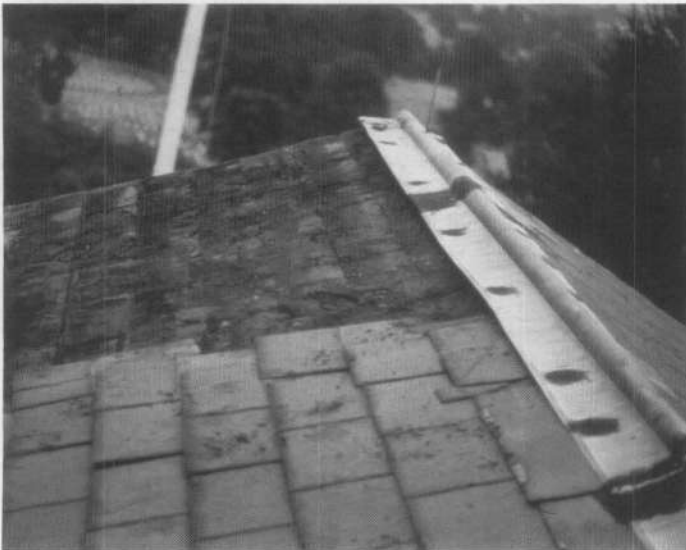
(c) Slate was removed in sections to avoid stress on timber framing.

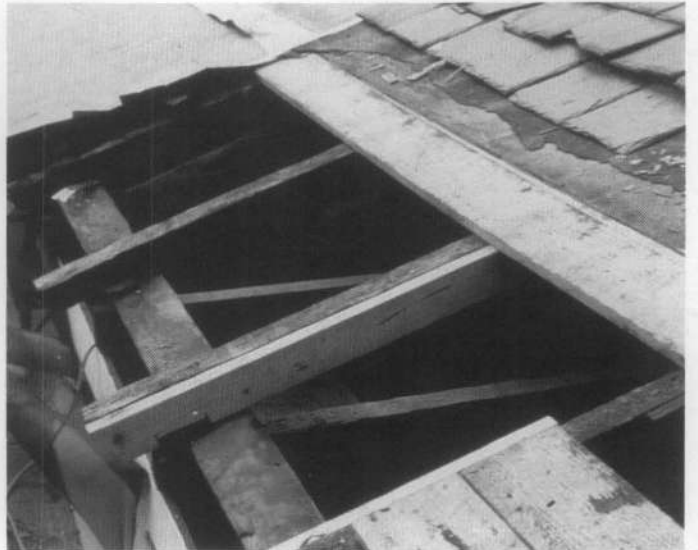
(d) Deteriorated sheathing was replaced and rafter tails were reinforced.

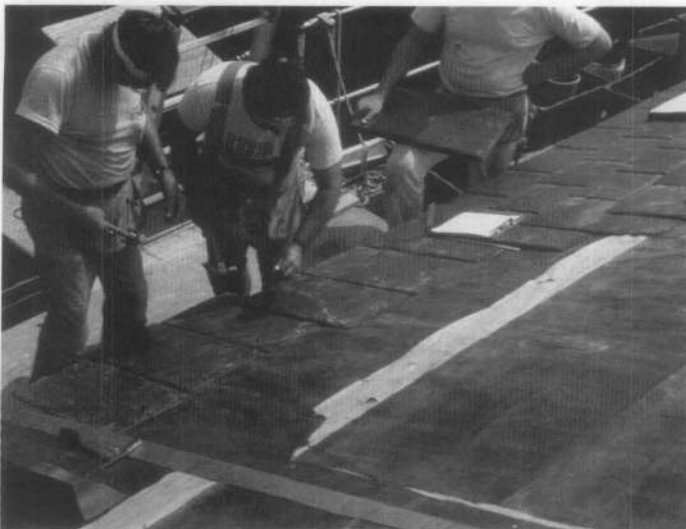
(e) Roofing felt was installed over decking; a rubberized membrane was used selectively at the eaves and under some flashing.

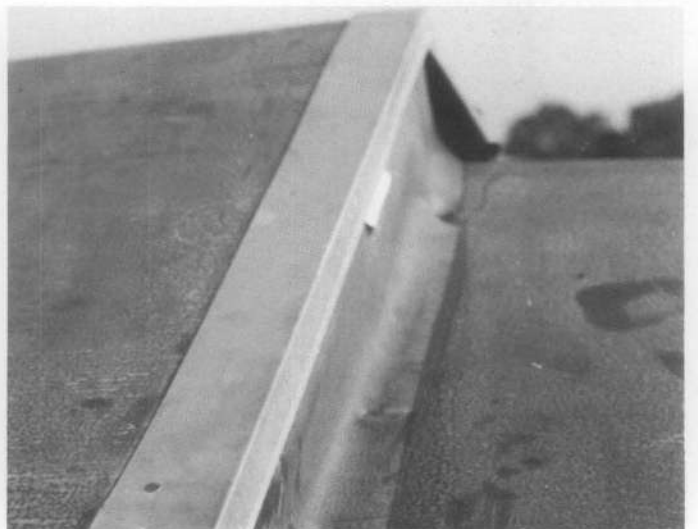
(f) Lead coated copper flashing was installed throughout. Seen is the offset between the portico roof and the main roof in progress.

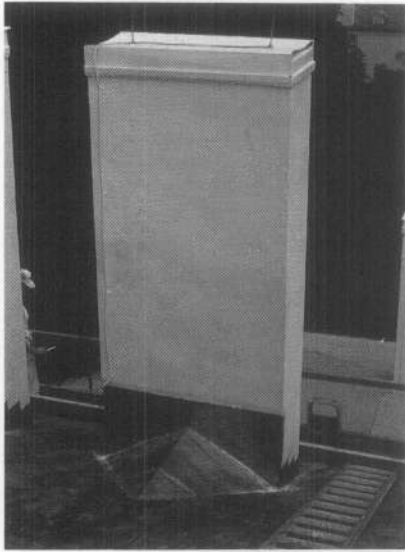
(g) Masonry chimneys were repaired and metal crickets were fabricated at the chimneys.

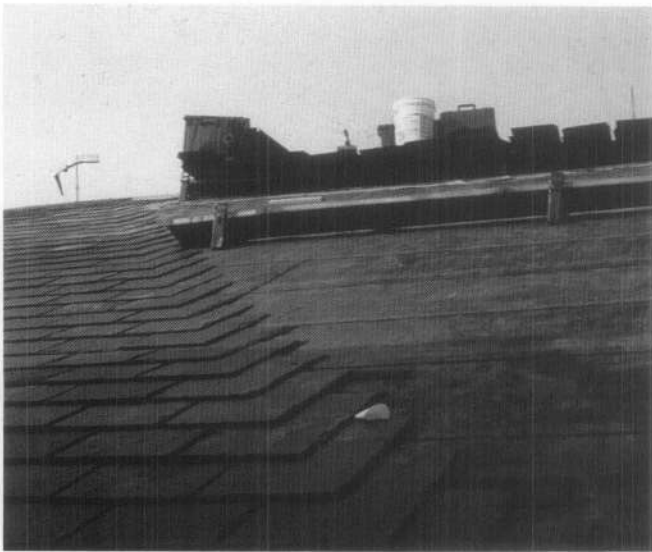
(h) This installation pattern allows the slates to be laid in courses leaving a temporary path of travel to avoid stepping on installed slates.

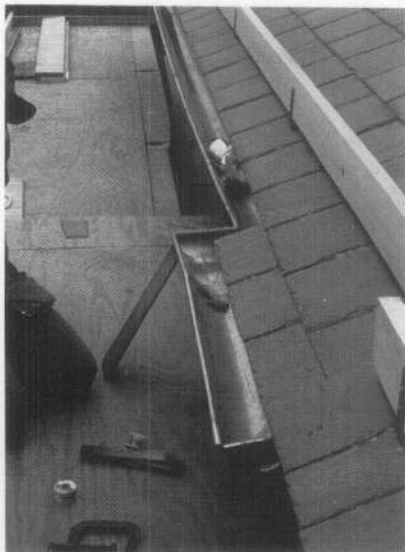
(i) Although the gutters and snow boards were the last elements installed, their support brackets were installed as the slates were laid.

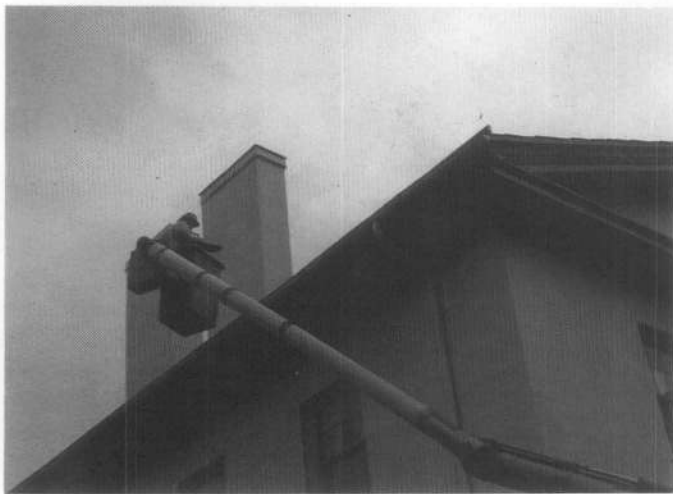
Figure 23. Slate roofs should not be walked on if at all possible. For large projects, lifts can be used to inspect roofs periodically to assess maintenance needs. Photograph courtesy of the National Park Service.
