Technical Bulletin #11 NATIONAL SLATE ASSOCIATION

Reuse Of Slate Shingles Exposed To Fire

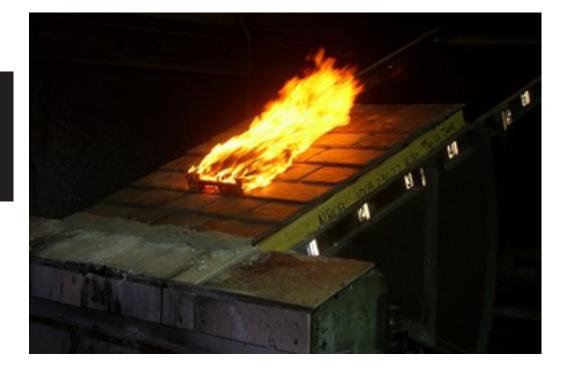
Figure 1: Slate roof assembly undergoing the burning brand test in accordance with UL 790, Standard Test Methods for Fire Tests of Roof Coverings.

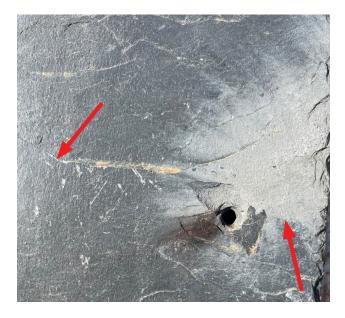
Figure 3: Discoloration (lightening; right arrow) and microcracking (left arrow) occurred in this slate shingle due to the heat generated when lightning struck one of its copper nails.⁹ (Photo courtesy of John Chan, The Durable Slate Company, Savage, MD)

• For the remaining slate shingles, they should be assessed for obvious signs of damage, such as discoloration and micro-cracking in color. Micro-cracking, if present, may be difficult to spot without the aid of a magnifying glass or wetting the surface of the slate and then looking for hairline crack lines as the slate dries. Slate shingles exhibiting color change or micro-cracking should not be reused.

ation and micro-cracking (Figure 3). Heat-induced color change is most pronounced in slates exposed to temperatures of approximately 840°F and upwards.⁶ At such temperatures it is common for slate shingles to take on a reddish tone due to the oxidation of iron ions, or become distinctly lighter

⁹Lightning itself, being an electrostatic discharge, does not have a temperature, but resistance to the movement of its electrical charges causes the materials through which the lightning is passing to heat up. Slate, being a poor conductor of electricity, will get very hot when lightning passes through it.
