Technical Bulletin #13

NATIONAL SLATE ASSOCIATION

Technical Bulletin No. 13: Matching Slate For Repair Or Replacement

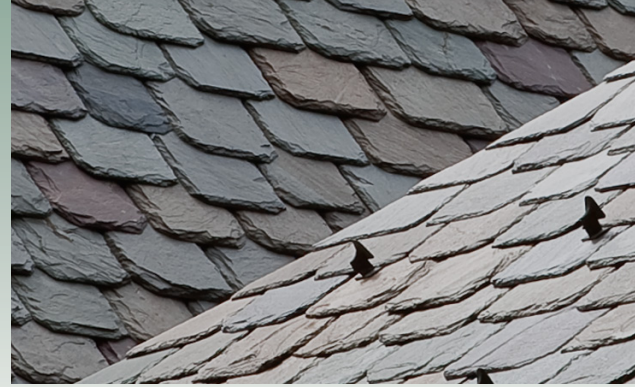
Figure 1: Mismatched Pennsylvania Black slate installed above the pole gutter on a New York/Vermont Semi-weathering Gray/Green slate roof.

All too often the replacement slates used in repair work,¹ or when replacing a slate roof that has reached the end of its service life, do not match the original slates (Figure 1). This is often not done with intention, but rather a lack of knowledge regarding what types of slate are available that might best match those that are being replaced.

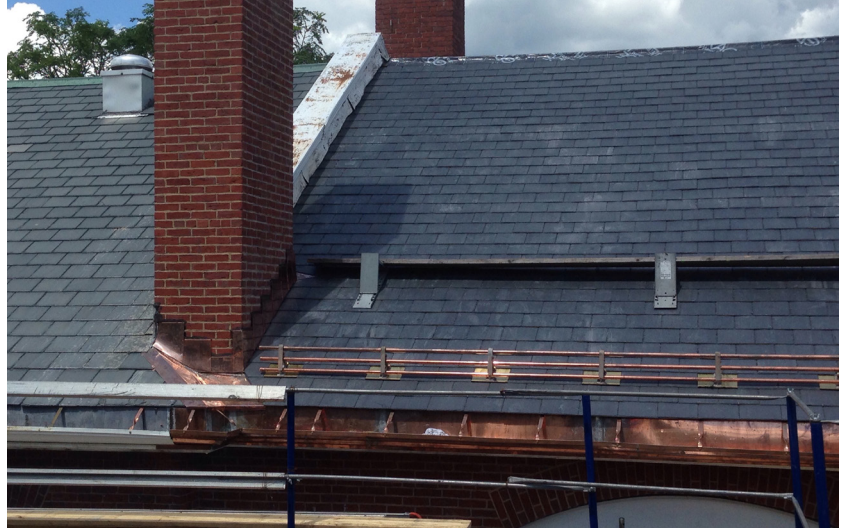
Figure 2: New North Country Black slate (right) is separated from existing Monson slate (left) by a party wall. When undertaking partial roof replacement, it is best not to place the replacement slate immediately adjacent to existing slate scheduled to remain. Rather, it is recommended that an entire roof area of the replacement slate be installed on a different slope, or otherwise visually separated from the existing slate sections.

- When undertaking partial roof replacement, try not to pick a line mid-slope as the dividing line between new and old. Rather, for a more pleasing transition, look for convenient transitions where new and existing will be isolated from each other, such as hips, party walls, or a large cross gable where only two or three courses may be present between the peak of the cross gable and ridge (Figure 2).

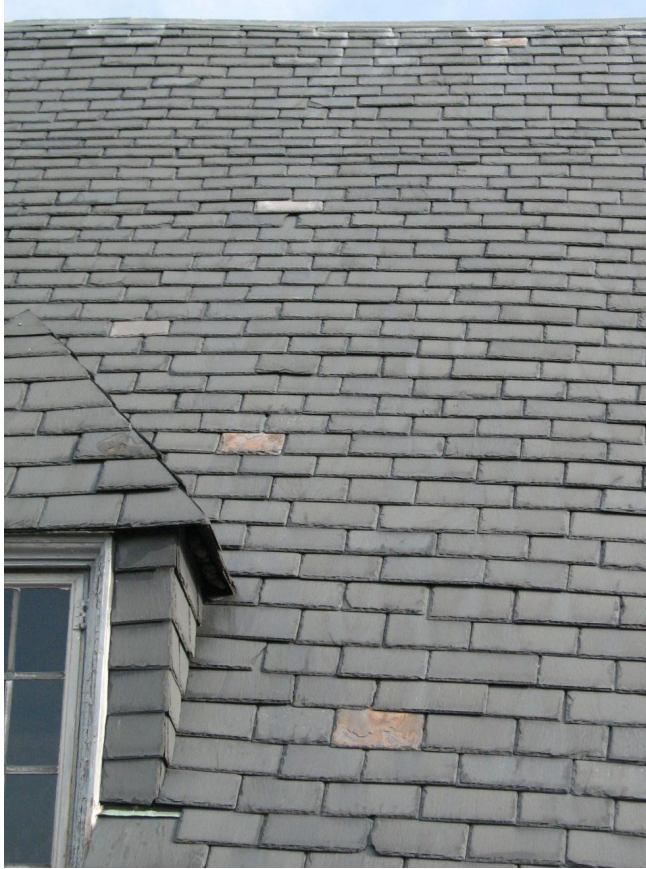
Figure 4: The five Pennsylvania Black slates used to repair this c.1924 Monson slate roof with varying exposures are not a good match. Three of the five replacement slates are nearing the end of their services lives (as evidenced by their surface delamination) and will need to be replaced yet again. (Interestingly, the varying exposures mentioned produced a wave effect when viewed from certain angles at grade.)

- Replacement slates used in repair work, whether new or salvaged, should possess a service life equal to or greater than the existing slate being repaired. For example, if a slate roof has an expected remaining service life of 100 years, and some broken or cracked slates need to be repaired, it is best to use replacement slates that have a similar expected remaining service life (see Figure 4).

other types of black slate, whether new or salvaged, to repair a Monson slate roof often results in a noticeable checkerboard or polka dot effect (Figure 4).

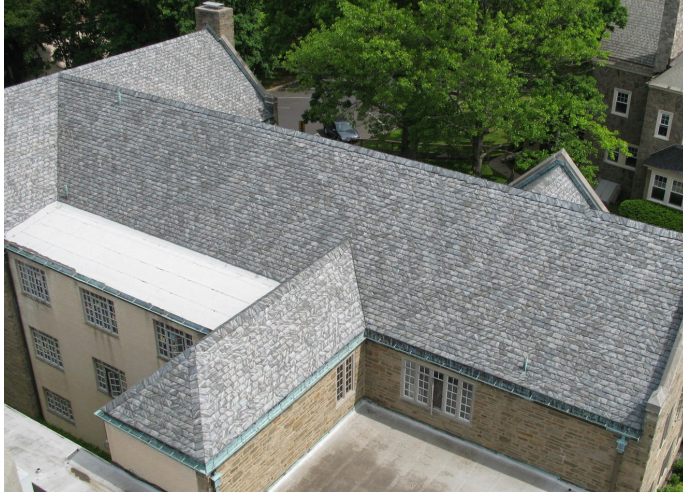
Figure 5: View of 80-year old Chapman slate on a roof in Glenside, Pennsylvania.

Chapman slate, from Northampton County, Pennsylvania, also known as Pennsylvania Hard-Vein, was a weathering blue/black slate characterized by closely spaced, dark colored ribbons that turned white, light gray, and orange over time to give the slate a streaked appearance (Figure 5). In certain environments, the slate took on a greenish hue as it weathered, especially when used as a wall cladding (Figure 6). While Chapman slate was very popular, especially in Pennsylvania's Delaware Valley, the quarries that produced it have been idle since the mid-1950s.

Chapman slate is unique; there just is no other slate that even comes close in appearance. As such, the best replacement slate for use in repair work is salvaged Chapman slate from a salvage company or slates harvested from a small, less visible area on the roof being repaired. Even then, as Figures 5 and 6 attest, the nearness of the match will depend on whether the salvaged slate was taken from a roof slope or vertical wall.

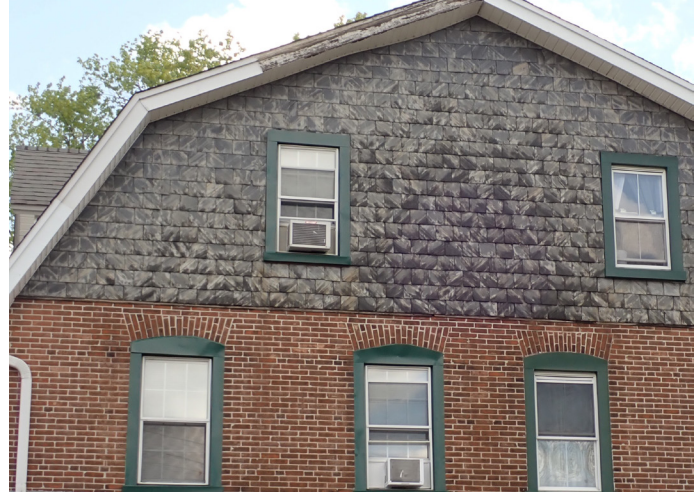
Figure 6: View of 100-year old Chapman slate cladding on a vertical wall in Ardmore, Pennsylvania that has taken on a greenish hue.

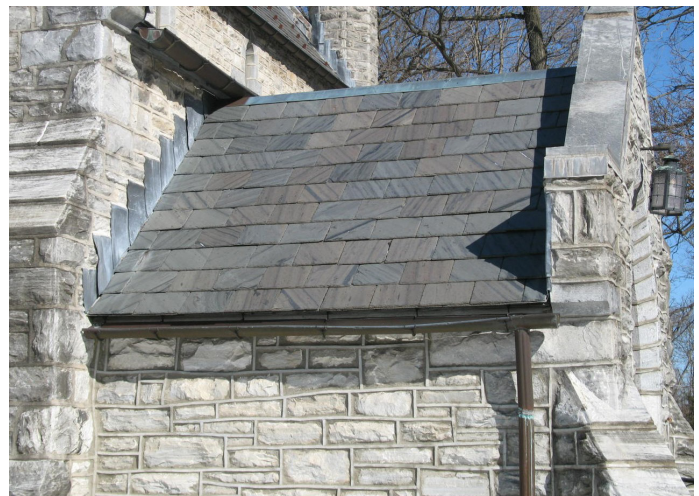
Figure 7: New York/Vermont Strata Gray can be used as a reasonable substitute for Chapman slate.

When replacing Chapman slate, there is no precise match, but a replacement slate that gives some impression of Chapman's streakiness is New York/Vermont Strata Gray, particularly after the Strata Gray weathers a bit (Figure 7). Besides their appearance, other differences to note between the two slates are that 1) whereas Chapman slate was typically split to a thickness of 3/16-inch to 1/4-inch, Strata Gray is typi-

cally offered at 1/4-3/8-inch, thus making the Strata Gray appear and, in reality, be a little heavier than Chapman, and 2) whereas Chapman presented a relatively smooth surface texture, that of Strata Gray tends toward more of a medium textured surface. These differences are generally not a problem if replacing an entire roof. If replacing only a portion of a Chapman-covered roof, it is best not to place Strata Gray slate immediately adjacent to Chapman slate. Rather, it is recommended that the Strata Gray be visually separated from the Chapman slate.

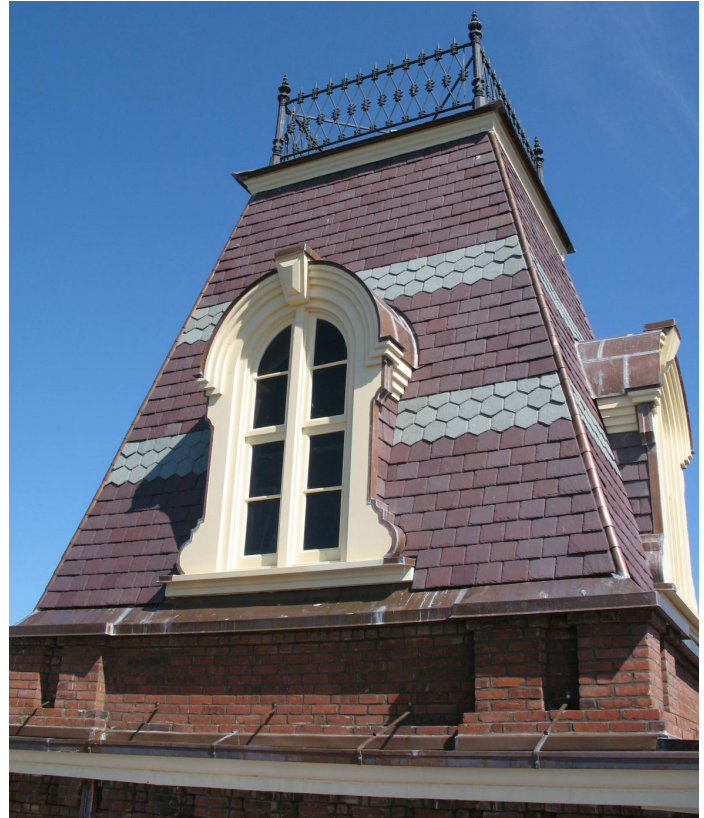
Figure 8: New Newfoundland Purple (aka Trinity Hues of Heather) and Vermont Unfading Green slate on a tower roof in Poughkeepsie, New York.
