# A PORTRAIT OF ROOFING

## WAGNER ROOFING HELPS TRANSFORM A SCHOOL INTO AN ART GALLERY

**Project name:** Rubell Museum DC  
**Project location:** Washington, D.C.  
**Project duration:** January 2021-September 2022  
**Roofing contractor:** Wagner Roofing Co., Hyattsville, Md.  
**Roof system types:** Copper, slate and TPO membrane  
**Roofing manufacturers:** Carlisle® WIP Products, Carlisle, Pa.; EDON Fiberglass, Cleveland; GAF® Parsippany, N.J.; Georgia-Pacific® Building Products, Atlanta; North Country Slate, Uxbridge, Ontario; Owens Corning, Toledo, Ohio; Revere Copper Products Inc., Rome, N.Y.

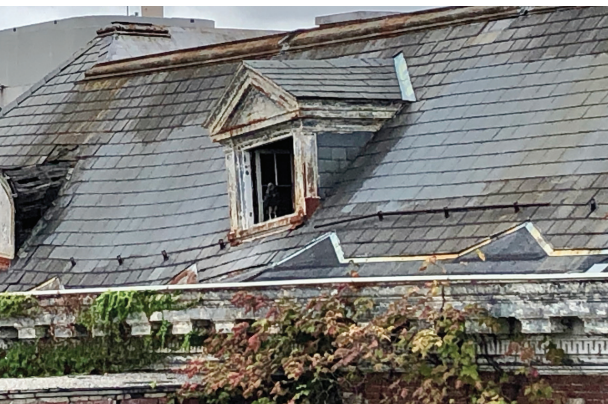
Before renovations, the building was in an advanced state of deterioration.

When the Wagner Roofing team joined the renovation project, the former school building was in a state of deterioration and neglect.

“Metal cladding had been stolen from the original dormers, leaving the facility completely exposed to the elements for years,” says Bob Kraft, president of Wagner Roofing. “The deterioration

and rot were so bad, phase one efforts focused solely on removing failed components and replacing roof joists and sheathing to temporarily protect the structure with new waterproofing until phase two of the restoration project could later commence in 2021.”

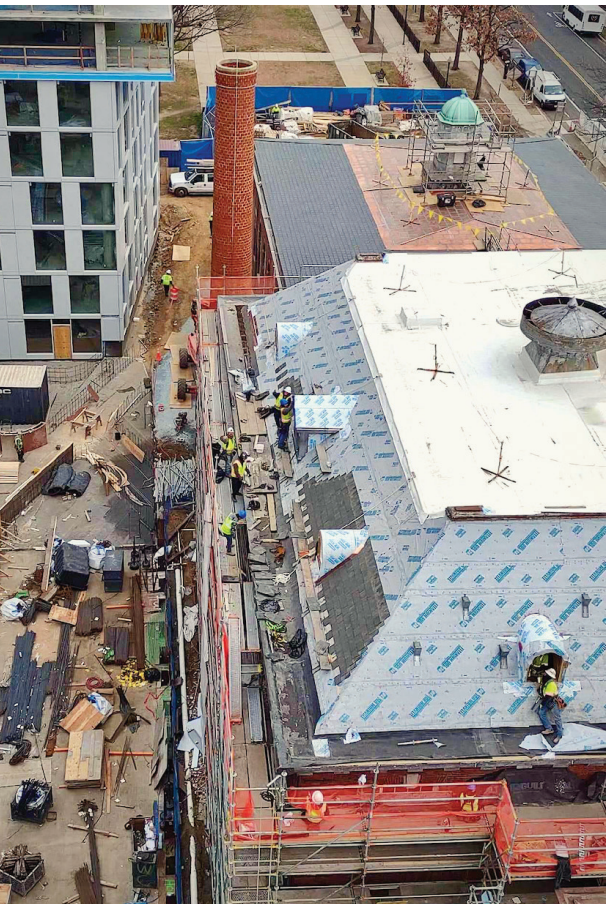
Aerial view of the new roof systems under construction

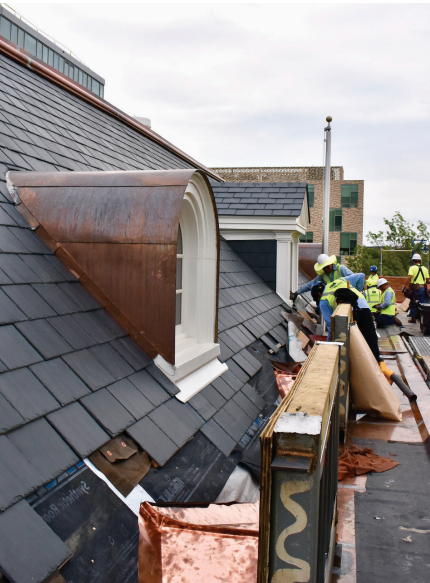
Wagner Roofing craftsmen fully restored 12 dormers.

The Wagner Roofing team of craftsmen also replicated and custom-fabricated 300 lineal feet of 16-ounce lead-coated Revere Copper decorative cornice, soffit and fascia; restored 12 existing dormers; restored the existing wood cupola structure to match the original design; restored the central building’s custom copper skylight with new

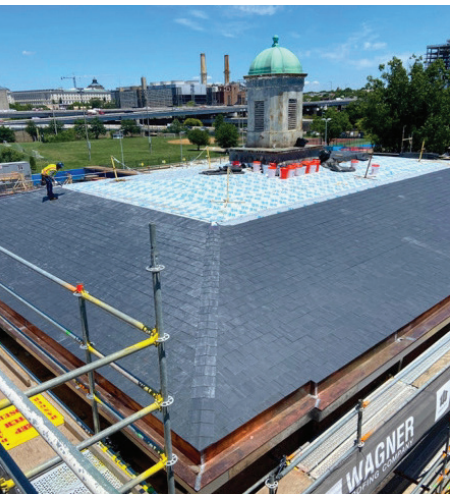
New slate roof system under construction

For the 5,900-square-foot slate roof, team members resurfaced the deteriorated lightweight concrete deck to accommodate new slate and then installed:

- 3/4-inch plywood adhered to the existing Creteplank® deck
- Carlisle® WIP 300HT self-adhering underlayment
- Owens Corning Titanium® UDL25 Synthetic Roofing

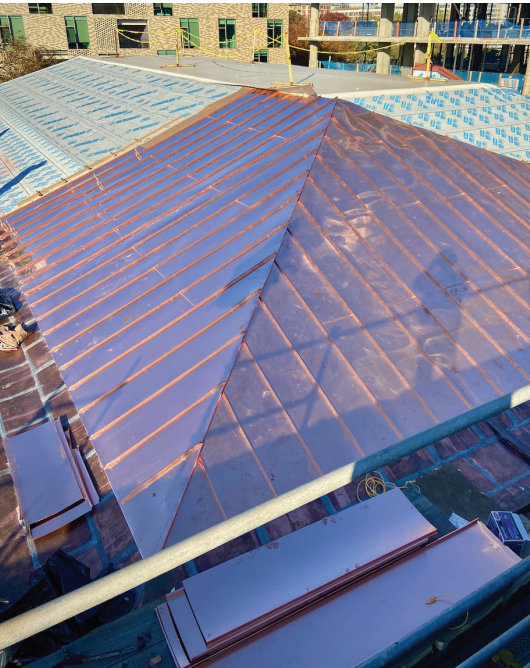
New standing-seam copper roof system in progress

For the 1,500-square-foot copper roof, Wagner Roofing craftsmen custom-fabricated 20-ounce Revere Copper double-locked, standing-seam panels to replicate the panels originally installed and fully soldered 20-ounce Revere Copper 18- by 24-inch flat-seam panels.

On the west wing's mansard, the team installed 4,350 square feet of 16-ounce Revere Copper 1-inch standing-seam panels; custom-fabricated, fully soldered 20-ounce Revere Copper built-in gutters with 16-ounce Revere Copper flashings and 4-inch round downspouts; and tied-in the gutter with 975-square-feet of custom-fabricated, fully soldered 20-ounce Revere Copper 18- by 24-inch flat-seam panels.
