Technical Bulletin #7 **NATIONAL SLATE ASSOCIATION**

Slate Roof Condition Assessment Surveys

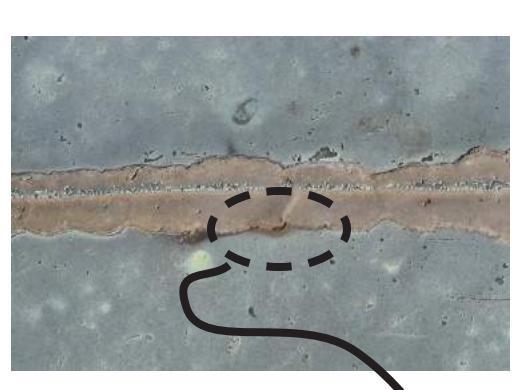
punctures, cracked soldered seams, fatigue cracking, pitting/pin holes along the edges of soldered seams (Figure 17), exposed fasteners, and base flashings that are not consistently spaced,⁸ are too short, or not well counterflashed (Figure 18). The list of possible counterflashing issues is quite long and includes:

Figure 17: Corrosion holes along a soldered seam in a copper flashing.

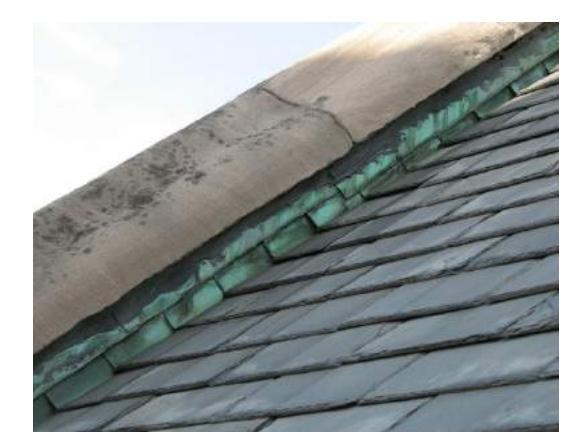
- Failed sealant or mortar in the counterflashing reglet
- Counterflashings that are too short to adequately cover the underlying base flashings (see Figure 18)
- Torn, bent, displaced, loose, and missing counterflashings
- Counterflashings that are set too close to the roof surface or stepped incorrectly, thereby limiting the height of the underlying base flashings (see Figure 18)
- Counterflashings secured with exposed fasteners, especially when those fasteners also penetrate the base flashings

Figure 18: On the left, base flashings, which are interwoven with each course of slate, are consistently spaced, but counterflashings are too short and do not provide sufficient cover over the base flashings. On the right, base flashings, although concealed, are known to be too short due to inappropriate layout of the stepped counterflashings. Extending the counterflashings to the right would have allowed for a full 4" vertical leg in the base flashings instead of the 1-3/4" to 2" that was achieved (see double-arrowed line).
