# ALL WAGNER ROOFING RESTORES HANDS FIVE ROOF SYSTEMS ON ON THE U.S. NAVAL ACADEMY'S ROOF MAHAN HALL DECK

BY CHRYSTINE ELLE HANUS

Reprinted with permission from *PROFESSIONAL ROOFING* magazine.  
December 2013 © by the National Roofing Contractors Association.

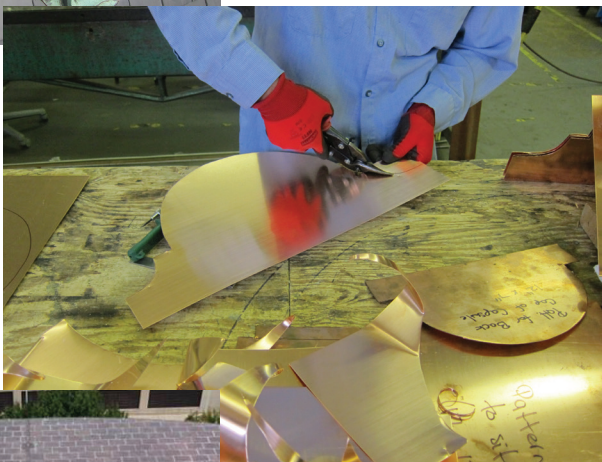
The 13 ornamental porthole dormers took five workers each to remove and reinstall. In many places, the copper had worn through and most of the soldered seams had either split or cracked from weather and wear during the past 104 years. The dormers were handled carefully so they would not be further damaged.

Top to bottom: Each dormer took about 120 man-hours to remove, repair and install; copper details were fabricated in Wagner Roofing's metal shop; the completed flat-seam copper roof system above the mansard

wanted the dormers salvaged and rebuilt with the original patina copper for historic and aesthetic reasons, once in its metal shop, Wagner Roofing had to detail how it would repair the dormers and submit it to the State Historic Preservation Office for approval.

After hours of discussion between Wagner Roofing and Gary Voth, a sheet metal expert from Texas, it was decided to replace the circular copper window tubes and upper crickets with new 20-ounce copper and reline the backs of the dormers' ornamental façades with new 20-ounce copper because these dormer parts were the least visible from the ground and would

patina quickly. Each dormer took about 120 man-hours to remove, repair and reinstall. The result is ornamental dormers that look 100 years old but are solid and waterproof.
