Going for the Gold

NRCA members receive Gold Circle Awards
for outstanding roofing projects

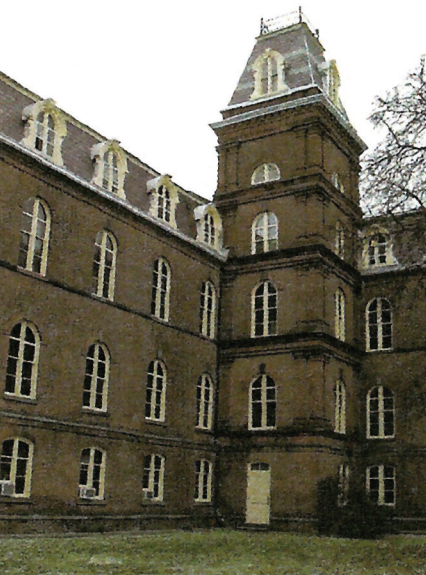
Photo courtesy of Vassar College, Poughkeepsie, N.Y.

Hayden Building Maintenance reroofed Vassar College’s Main Building.

First, Hayden Building Maintenance carefully removed the iron balustrade. The salvaged pieces would later be prepped, primed, painted and reinstalled. Next, all slate was removed down to the wood. Dormers, the metal skirt and the copper-lined gutter also were removed.

All rotted wood from the deck was removed and replaced with new wood. Hayden Building Maintenance then installed new copper drip edge metal with an integral cant at the eave and new North Country Slate shingles.

Existing copper hip flashings and rotted upper wood molding also were replaced. New copper hip flashings were installed

to match the originals, interwoven with each slate course.

Finally, Hayden Building Maintenance installed new dormers and replaced the copper gutters.

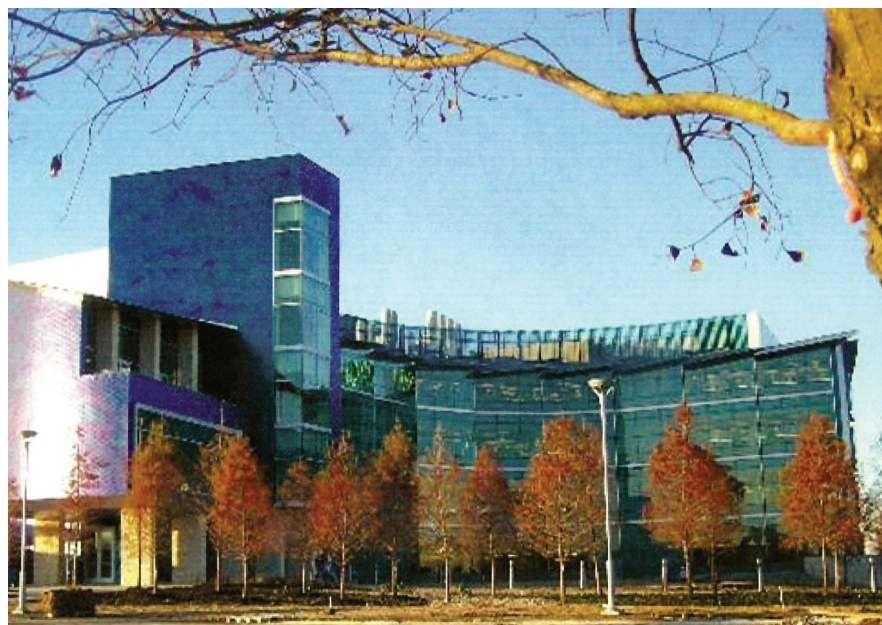
Photo courtesy of Architectural Building Components, Houston

KPost installed a standing-seam metal roof system on the University of Texas at Dallas’ Natural Science & Engineering Research Laboratory in Richardson.

“The beaks were designed through several mock-ups and installed in place before the final fabrication,” Little says. “To achieve the knife-edge look, we tried and tested several options. The final design consisted of 22-gauge brushed stainless steel with 20-gauge clips to hold the beak portions in place.”

KPost then covered the beaks with a 45-mil-thick EPDM membrane. Before installing an Architectural Building Components 200 Series 24-gauge 18-inch-wide Galvalume® Plus™ standing-seam metal roof system with 2-inch high-locked seams, KPost installed all 22-gauge stainless-steel soffit panels, 24-gauge stainless-steel rise-wall flashings and beaks. The ends of the corner beaks were welded into place.

“Each roof deck sloped in at least two directions in most cases because of the building’s structure,” Little says. “The complicated part was tying in the stainless-steel beaks to the standing-seam metal roof system. The standing-seam roof stopped 2 feet short of the roof surface exterior, making each tie-in point unusual.”

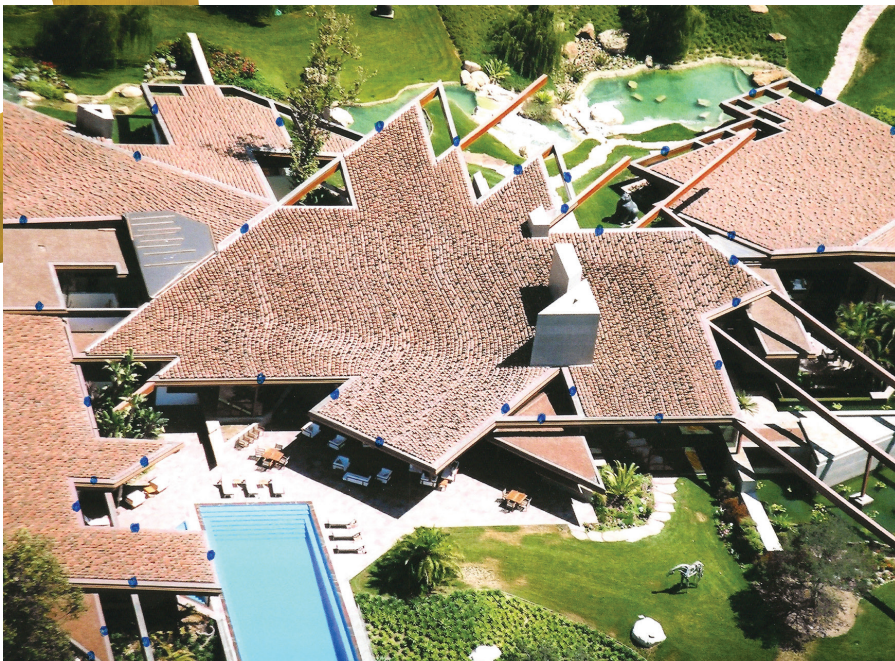
Photo courtesy of Keystone Roofing Inc., Oceanside, Calif.

Keystone Roofing installed a clay tile roof system on this private estate in California.

To meet the owner's request, Redland Clay Tile roof tiles were molded into pan shapes specifically for the project. Special molds were made, used and broken so no one would be able to replicate the shapes.

Keystone Roofing installed a six-layer GAF Materials polymer-modified bitumen roof system on the estate. The roof was picture-framed with 37-ounce copper trim flashing and outrigger beam cladding that is twice the thickness called for in standard residential requirements. Additionally, 37-ounce copper perforated drains were installed.

"Every piece of 37-ounce cladding was hand-crafted on-site," Katona says. "A stainless-steel Twisted Wire Tyle Tye® System was installed to hold every tile in place."

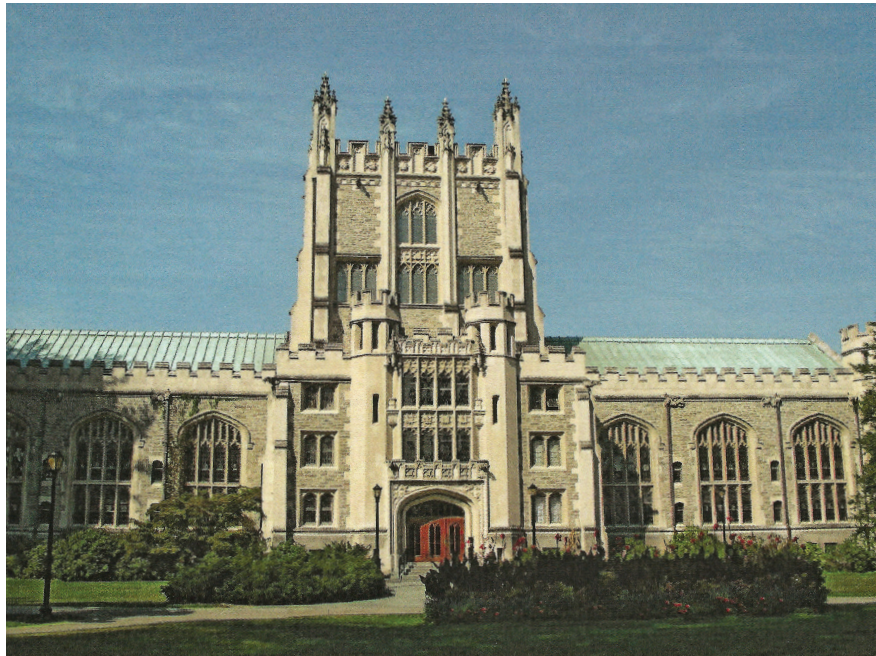
Photo courtesy of Levine & Co. Inc., Ardmore, Pa.

Hayden Building Maintenance reroofed Vassar College’s Frederick Ferris Thompson Memorial Library.

Hayden Building Maintenance removed all existing membranes and flashings down to the gutters’ wood framing members. Crew members then replaced the deteriorated framing and installed new sloped gutter sheathing.

Next, mastic residues were removed from the parapet walls and a Liquid Plastics 3-ply DECOTHANE sp system was applied. And because the batten-seam copper roof system was to remain in place, Hayden Building Maintenance installed an intricate copper apron flashing to bridge the interface between the batten-seam roof and the new gutter liner’s top edge.

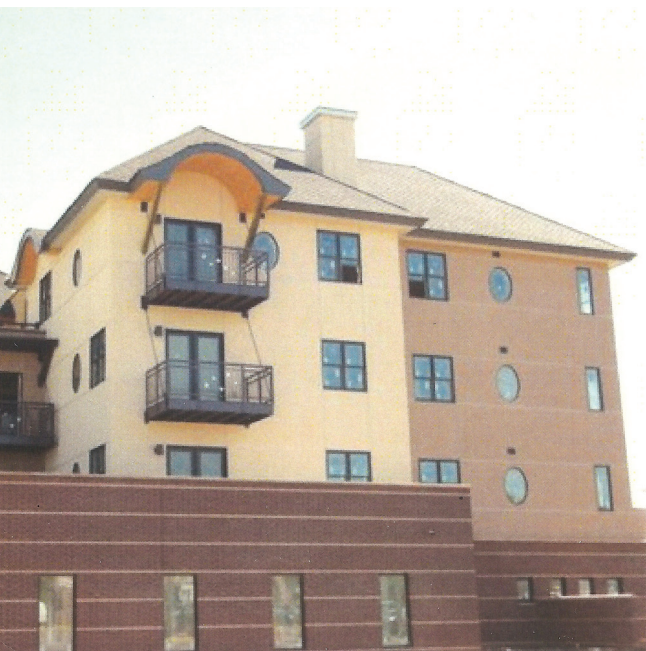
Photo courtesy of Brent's Place, Denver

The Colorado Roofing Association donated a roof system to Brent's Place.

The four-story building has several roof areas and required two roof system types. On the low-slope roof areas, the crews installed 125 squares of EPDM. Additionally,

1,200 square feet of plaza pavers were installed, and reflective coatings were applied.
