ROOFING ON A CURVE

Ruff Roofers raises the grade at The Johns Hopkins University's Gilman Hall

Project name: The Johns Hopkins University's Gilman Hall

Roof system types: Copper; EPDM; slate

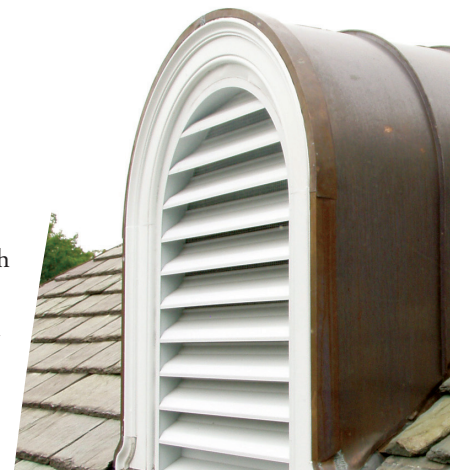
Curved copper standing seams over a barreled roofed dormer

The curved copper standing-seam roof system is on barreled roof dormers. Tearing off the copper dormers to wood deck required careful staging to avoid damaging the surrounding slate during removal and installation. Twenty standing-seam copper barreled dormers were roll-formed in Ruff Roofers' shop. Each panel then was custom-curved to fit dormers. Attention to joint placement was essential to the finished appearance. Single panels were curved and straight to fit the dormer shape without the need to place a joint at the point of tangency. Precision field measuring and fabrication were key elements to producing a neat finish on every dormer.

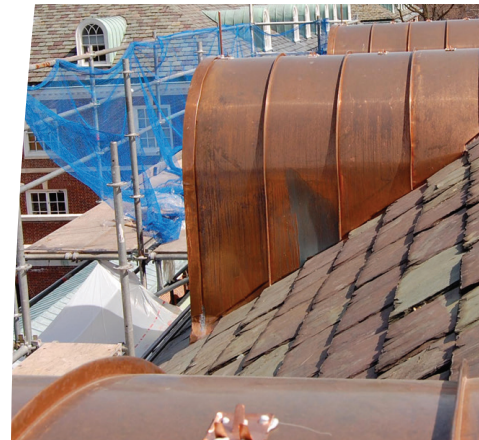
Random locations of slate repairs required precise fitting and color blending.

In addition to the copper work, repairs were made to slate and membrane roof systems. Slate roof system work consisted of limited replacement of missing or damaged slate. In some areas, individual pieces of slate needed to be removed without damaging adjacent slate. In other areas, large areas of slate were removed and replaced. Random locations of repairs required precise fitting and color blending to avoid unevenness of sizes, gaps and colors on the mottled purple and green, random width, graduated slate roof system. Slate was provided by North Country Slate.*

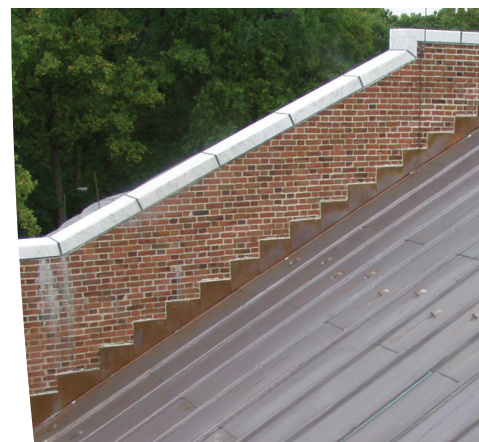
Individually cut stepped wall flashing and transverse joints

for the project was provided by Revere Copper Products Inc. Each piece was produced in 10-foot lengths to replicate and maintain the historic method of fabricating sheet-metal roof panels. Modern fabrication methods allow greater panels lengths; however, Ruff Roofers crafted the panels in the same historic manner the original panels had been crafted. The batten seams of each roof panel were folded in a consistent manner, and each piece of stepped wall flashing was individually cut and shaped by skilled copper tradesmen to produce a clean finished product. Ruff Roofers' workers demonstrated great care and precision in the panel layout. Using hand tools, the transverse joints were aligned in a symmetrical pattern, and

the batten ridge joints are meticulously neat and uniform.

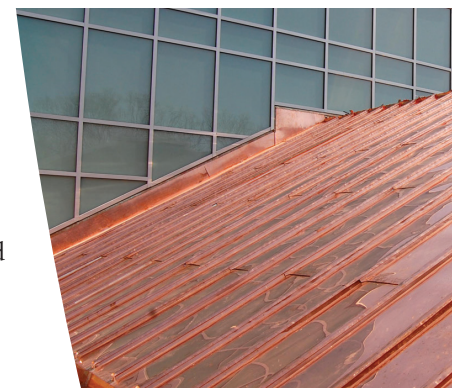
Batten-seam copper on a gable roof

The batten-seam copper roof system covers a gable roof flashed into brick walls. All copper
