## Re-creating architectural history at Harvard University

Using original 19th century drawings, architects restored the Memorial Hall tower at Harvard University, to replicate the design created during its first erection in the 1870s

## Memorial Hall at Harvard University Boston, MA

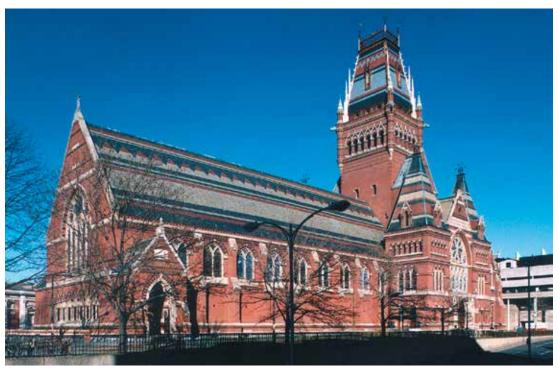
Combining North Country Unfading Black, Unfading Red, and Unfading Green slate with buff-colored sandstone, the Memorial Hall tower at Harvard University was restored to its original 1870s appearance.

With the exception of its copper rooftop and ornamental accent pieces, the majority of the tower is clad in polychrome stripes of slate. Adding up to almost 70 squares of roofing material, these sidewalls consist of North Country Unfading Black, Unfading Red and Unfading Green slate.

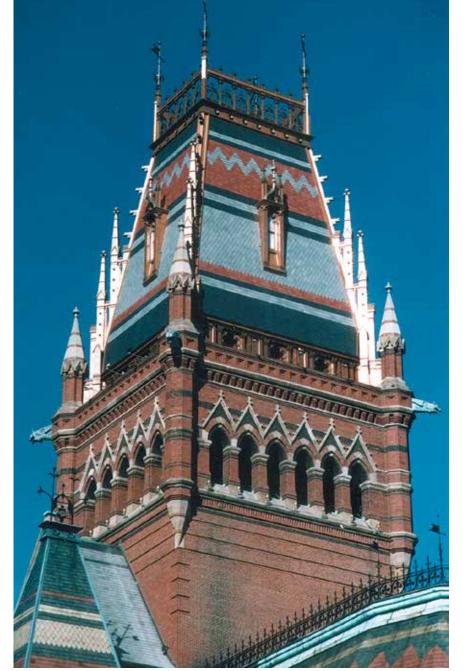
With its copper roof, slate siding and sandstone pinnacles, architects and installers worked from early drawings to capture the original architect's intent.

In addition to the surface appearance, the project also required that the stone and copper to be installed had to meet historic specifications. "The aspects of layout and details made it a difficult installation," said John Marcone, project manager at Gilbert and Becker Co. in Boston, MA. "Because we were duplicating what was initially there, we had to work from the early drawings."

According to Marcone, the slate was laid as shingle siding, and the

pieces were 8 x 16 inches, with some cut to a point. "The slate was installed using copper nails," he said. "We used two nails on the top of each slate, and because of the way they were hung, you can't notice them. With the shingle effect, the nails are not exposed."

Gilbert and Becker Co. was also in charge of installing the copper roof and detailing. According to Marcone, the roof was flat-seamed and soldered, and the detailing was cut-to-size and bent. Installing both the slate and the copper simultaneously, the job took approximately three and a half months to complete.

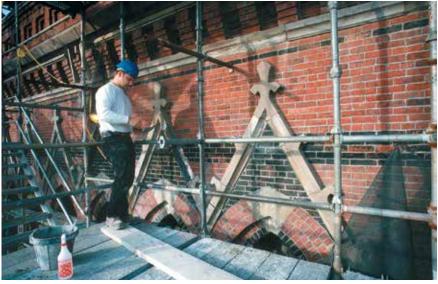
According to Dr. Judith E. Selwyn of Preservation Technology Associates in Boston, MA, the sandstone pieces with minor damage were tooled back to a new surface.

Also keeping with the past design, the buff-colored sandstone pinnacles were repaired and replaced where necessary. "We replaced 50 or 60 stones," said Selwyn. "The ones with more minor damage were tooled back to a new surface, which left them slightly recessed. But if they were damaged more than that, they were patched or replaced."

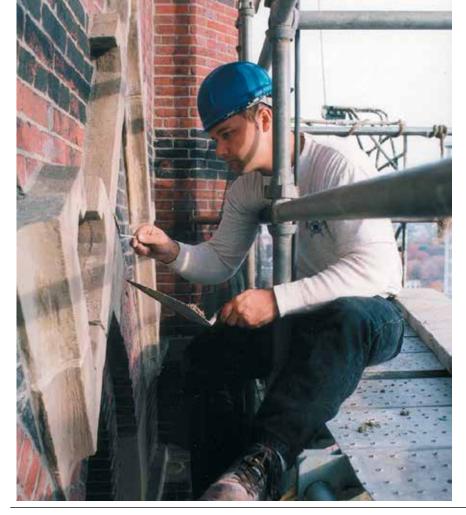
If more severe damage was found, the stone was patched or replaced.

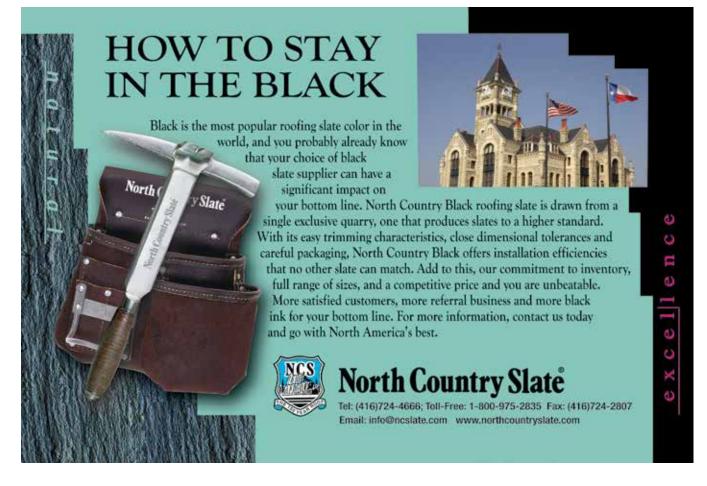
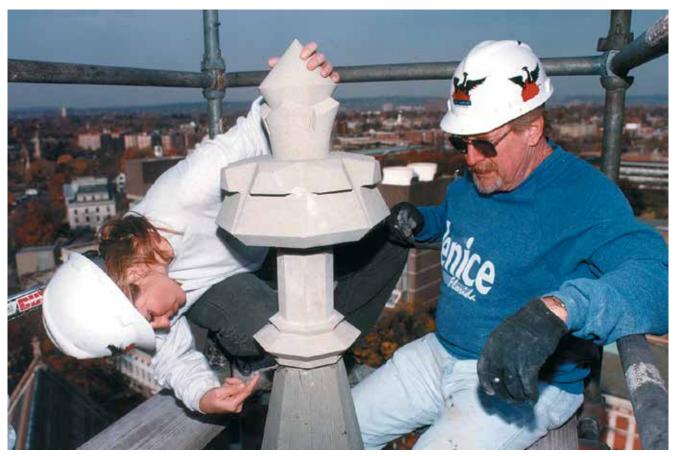
Approximately 50 or 60 stones were replaced during the restoration of the sandstone pinnacles.

Another aspect considered was the stone finish. While taking the original design into account, the new design presents a slightly modified version. "Some of the material has a smooth or sawn face, and while some of the original stone has vertical tooling, we did not do that on all of the new stone because of both cost and time," said Selwyn. "Since you see the tower at quite a distance, you can't see the details of it."
