# Roofing around the clock

## Renaissance Historic Exteriors helps restore Green County Courthouse in Wisconsin

**Project name:**  
Green County  
Courthouse

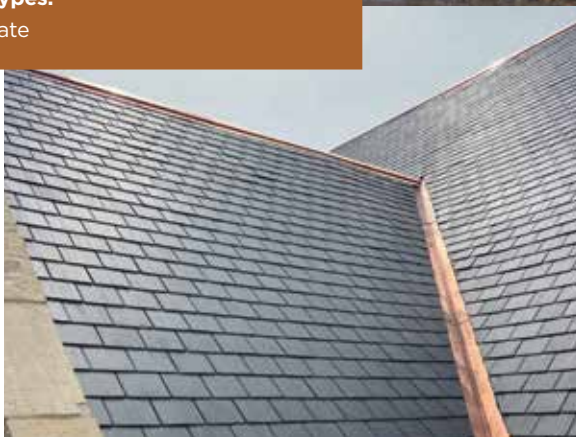
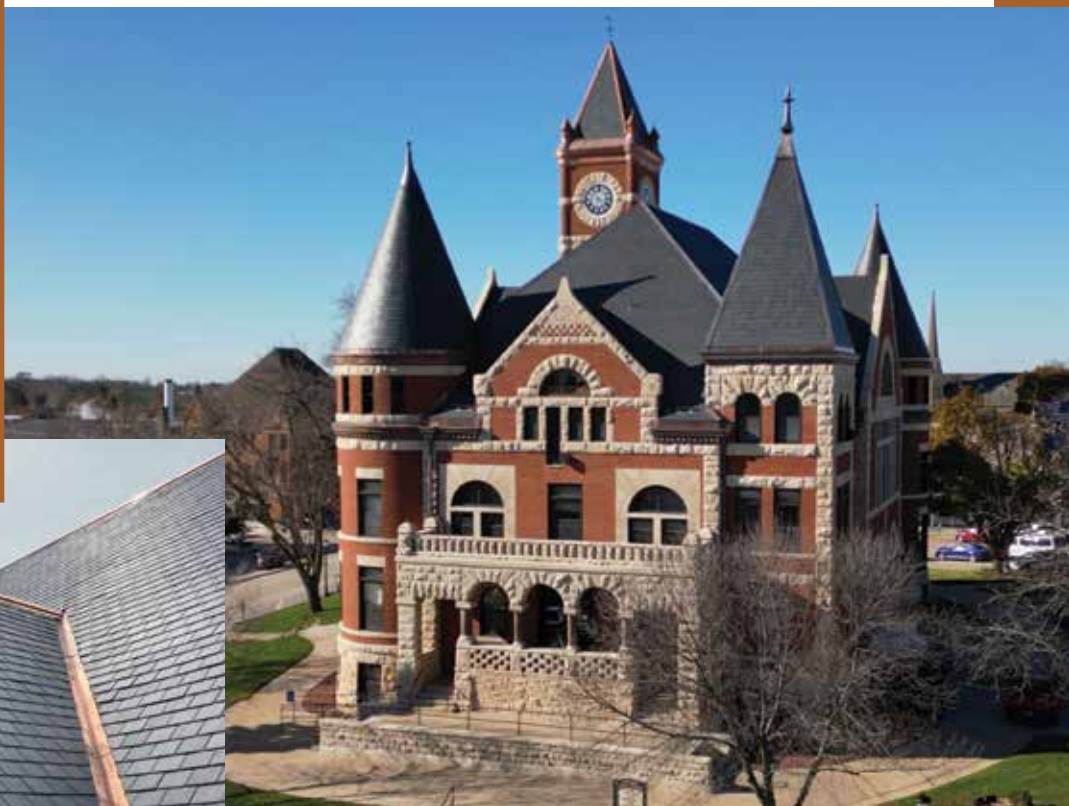
Left and above: Thousands of slates were installed on the courthouse roof.

Thousands of North Country slates in Unfading Black were installed on the roof with copper slating nails to build the courthouse’s new roof that included MBTechnology TU43 Layfast SBS Underlayment and Grace Ice & Water Shield® self-adhering roofing underlayment.

“Two steep-slope round turrets required detailed and careful tapering of slates,” Raleigh says. “And one steep-slope pyramid turret was difficult to access, requiring significant fall protection, planning and monitoring.”

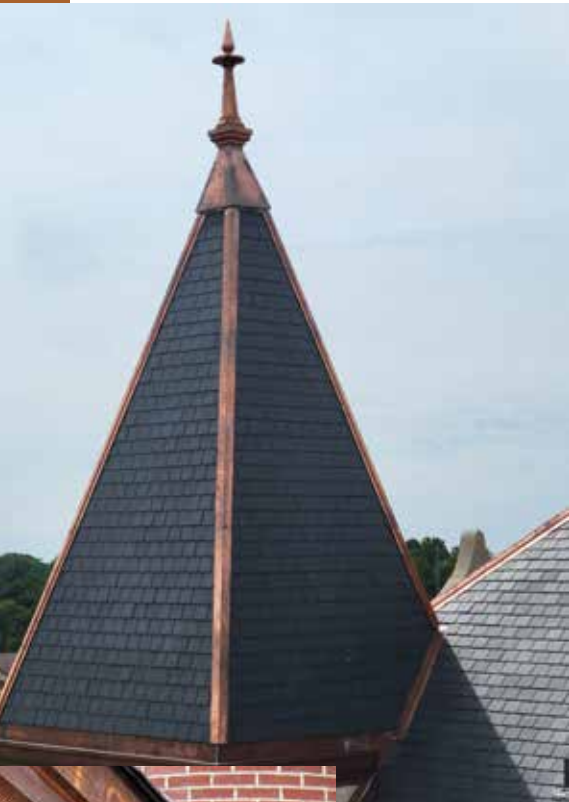
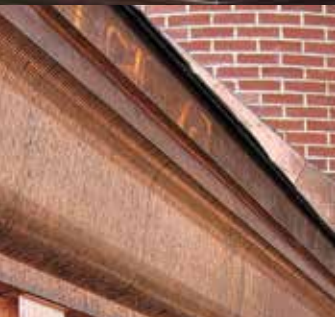
Above and left: All copper elements were fabricated by Renaissance Historic craftsmen.

All copper elements were fabricated by Renaissance Historic Exteriors craftsmen with Revere™ copper. This included gutters, downspouts and cornices.

Working in Renaissance Historic Exteriors' in-house copper studio, the team of artisans used existing components and historical photos to guide them as they carefully replicated sheet-metal cornices, finials, modillions, dentils and spires to match the originals. Several of the fabricated pieces required aerial lifts and crane services to install on the roof.

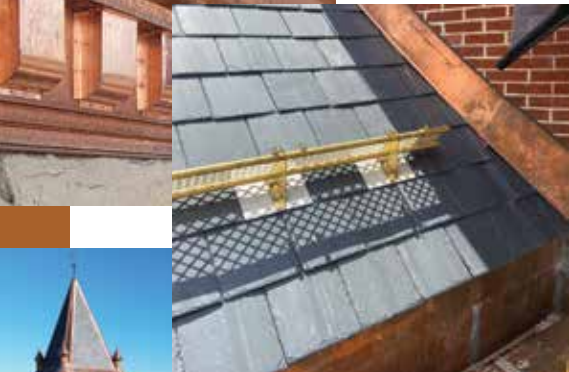
Above: Snow guards were incorporated into the roof system.

To protect the newly restored gutters and architectural sheet-metal cornice, the team incorporated Alpine Snow-Guards® into the roof system.

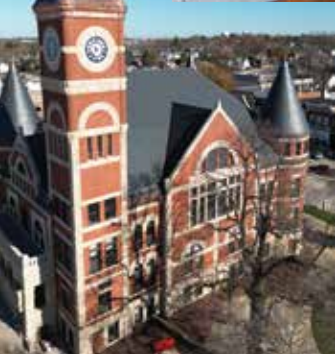
Left: Aerial view of newly completed courthouse roof
